PROJECT MANUAL APPENDIX EPPS-MCGILL FARMHOUSE

MEADORS, Inc.

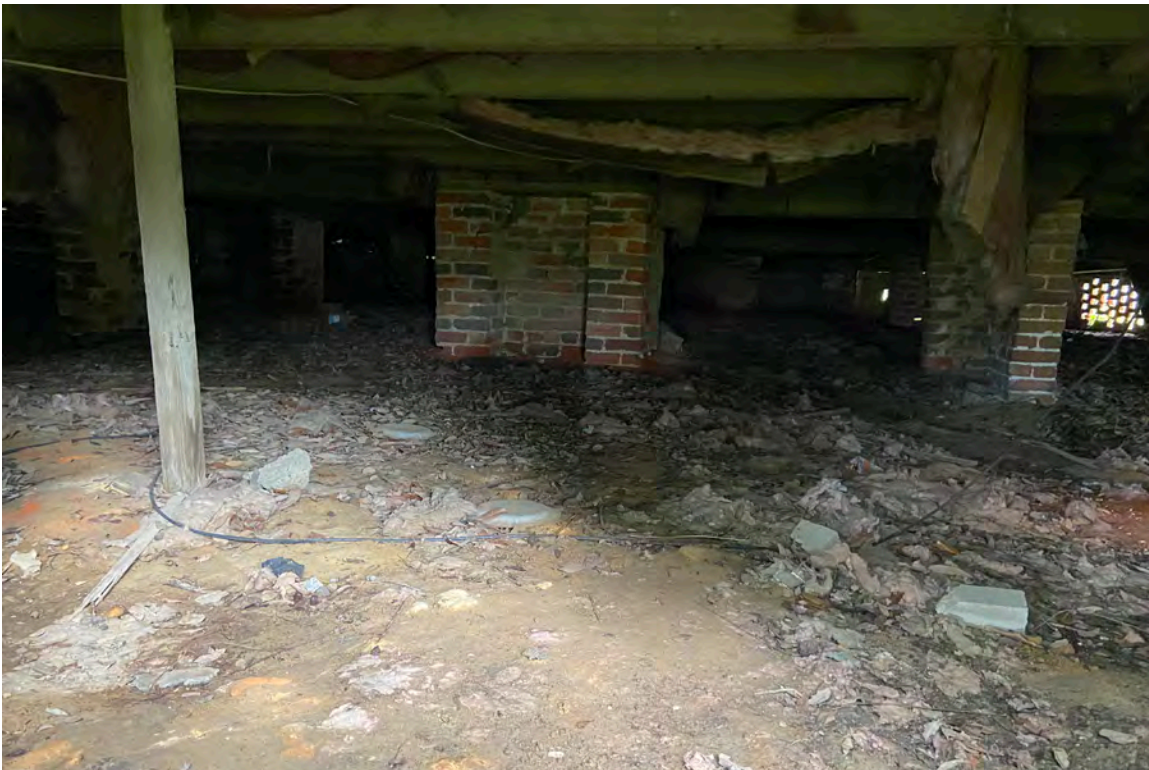
Figure 18: Epps-McGill Farmhouse, Crawlspace: Detail of Chimney Foundations (Kalen McNabb 2020).

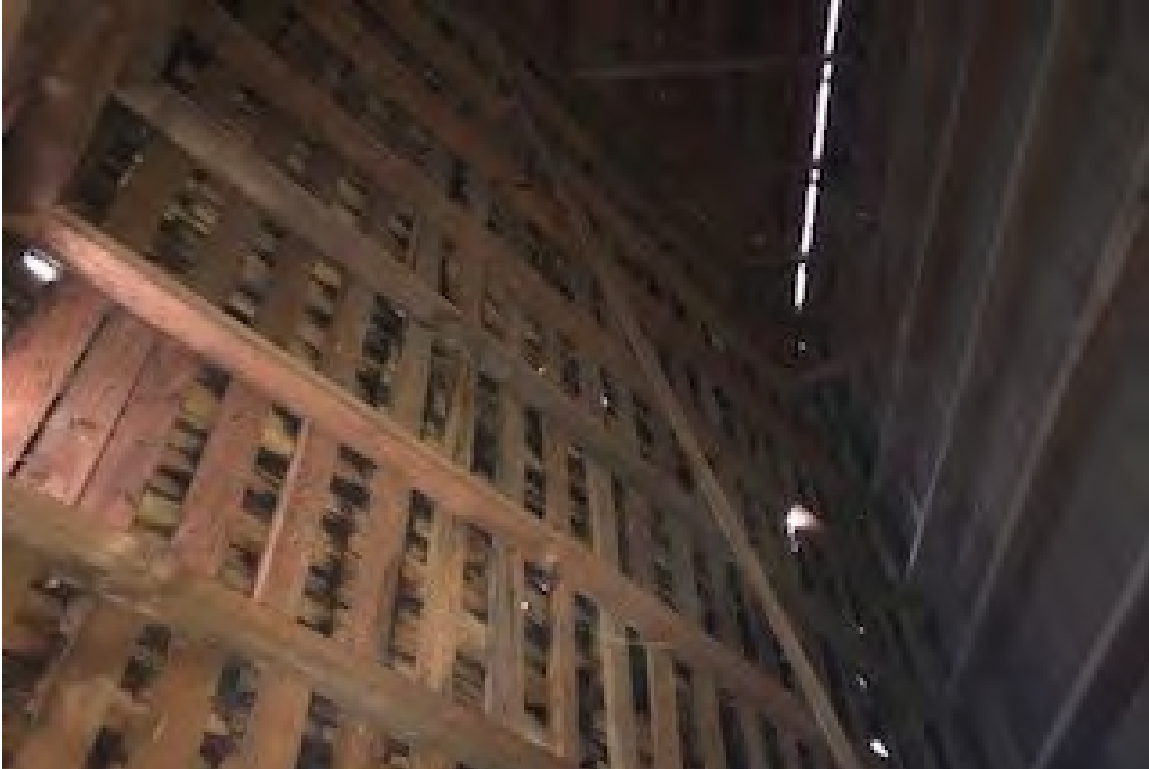
Figure 19: Epps-McGill Farmhouse: Overview of Attic and Framing (Mike Hance 2021).

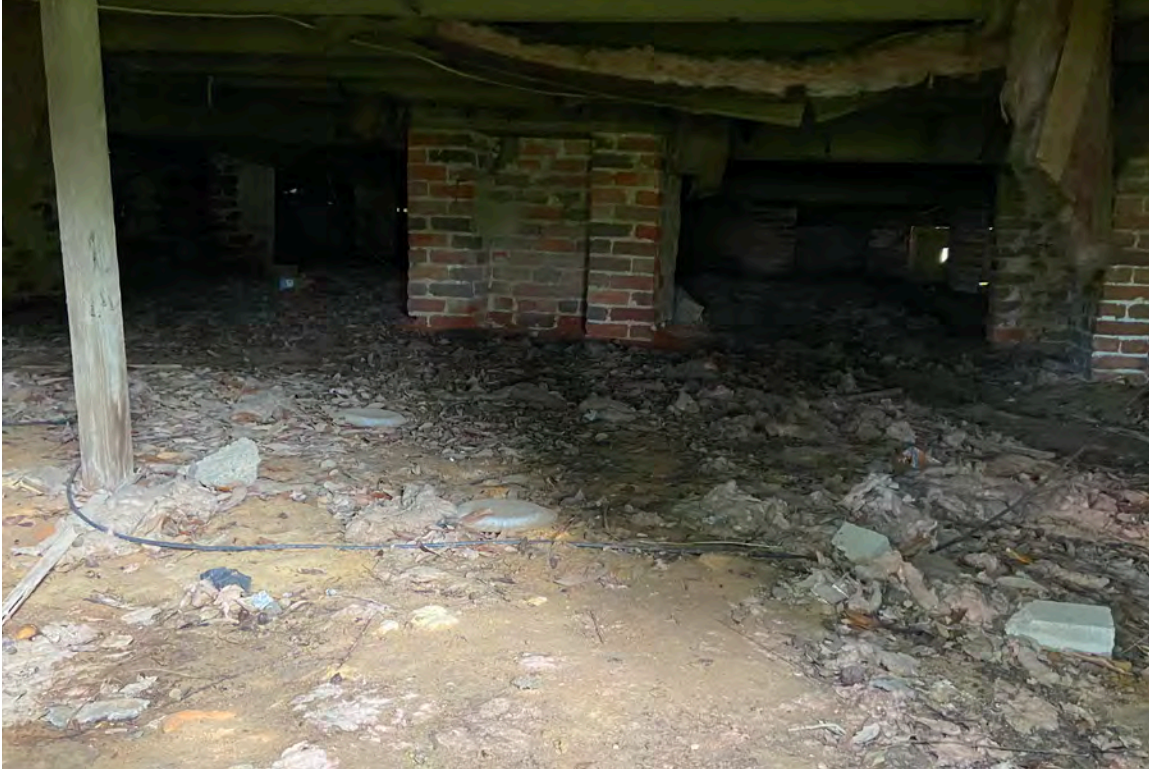
Figure 1: Epps-McGill Farmhouse - PHASE 01: Overview of the crawlspace (Kalen McNabb 2020).

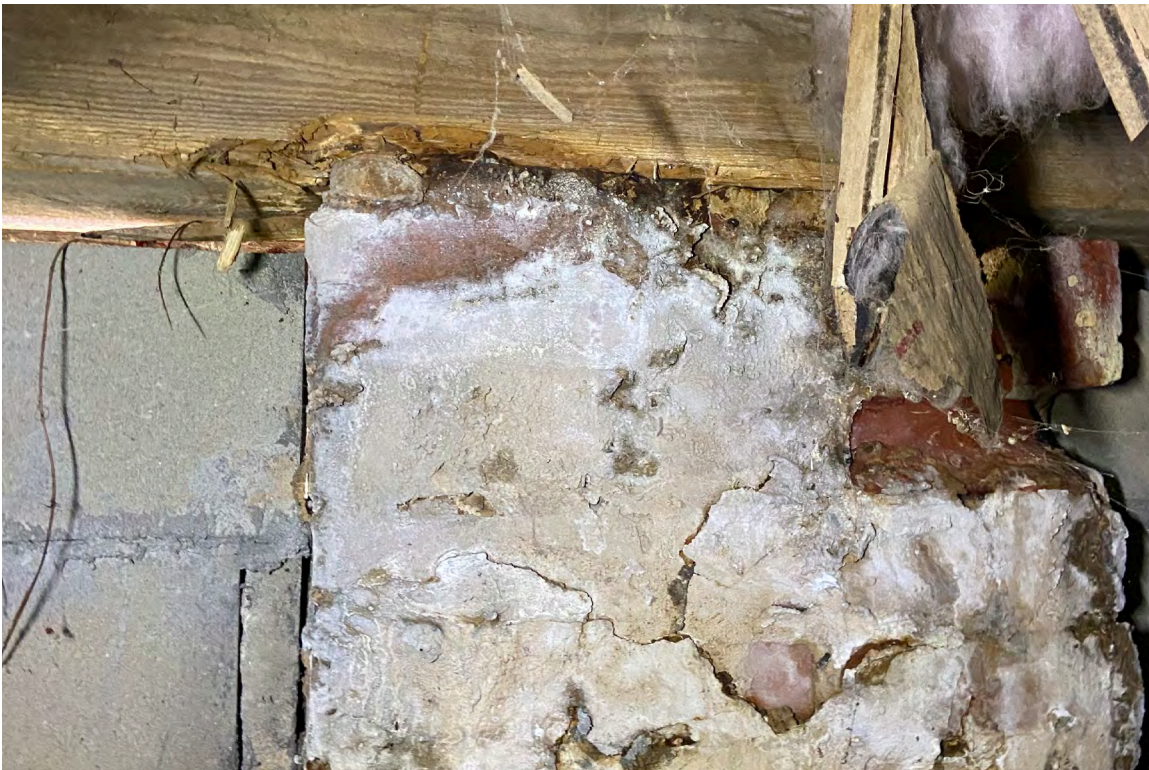
Figure 2: Epps-McGill Farmhouse - PHASE 01: Detail of masonry deterioration and efflorescence (Kalen McNabb 2020).

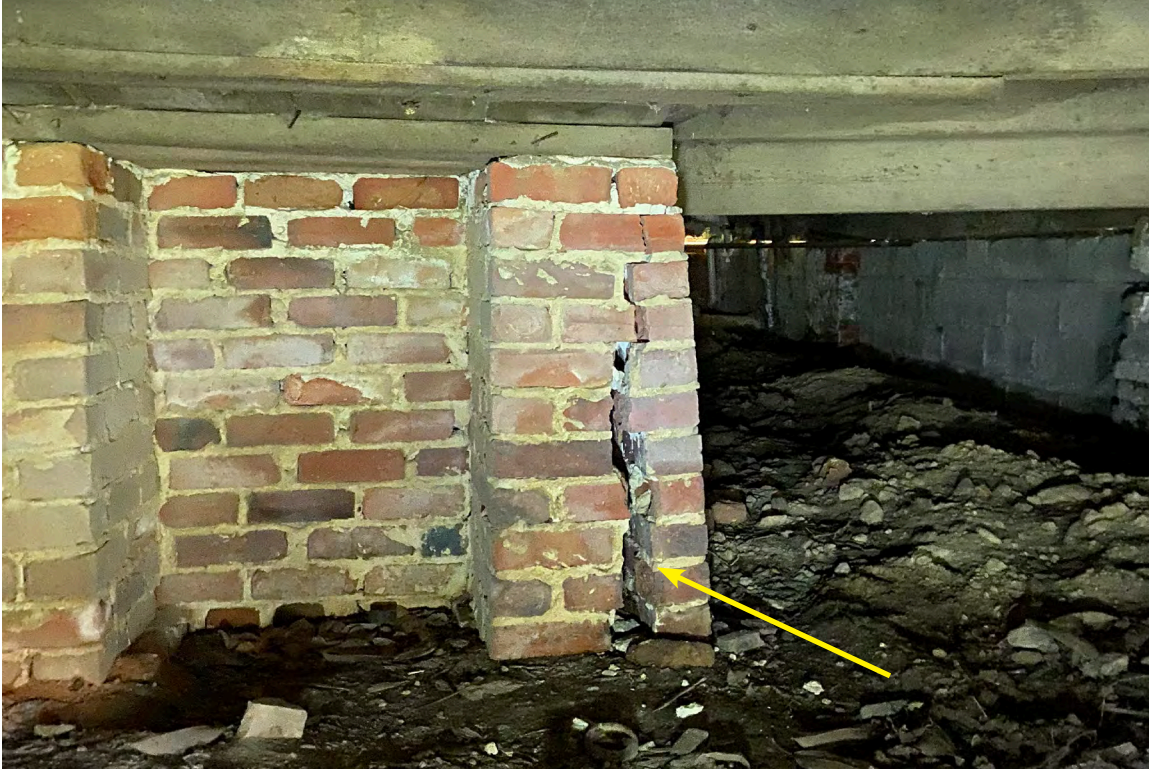
Figure 3: Epps-McGill Farmhouse - PHASE 01: The north foundation chimney is cracked (Kalen McNabb 2020).

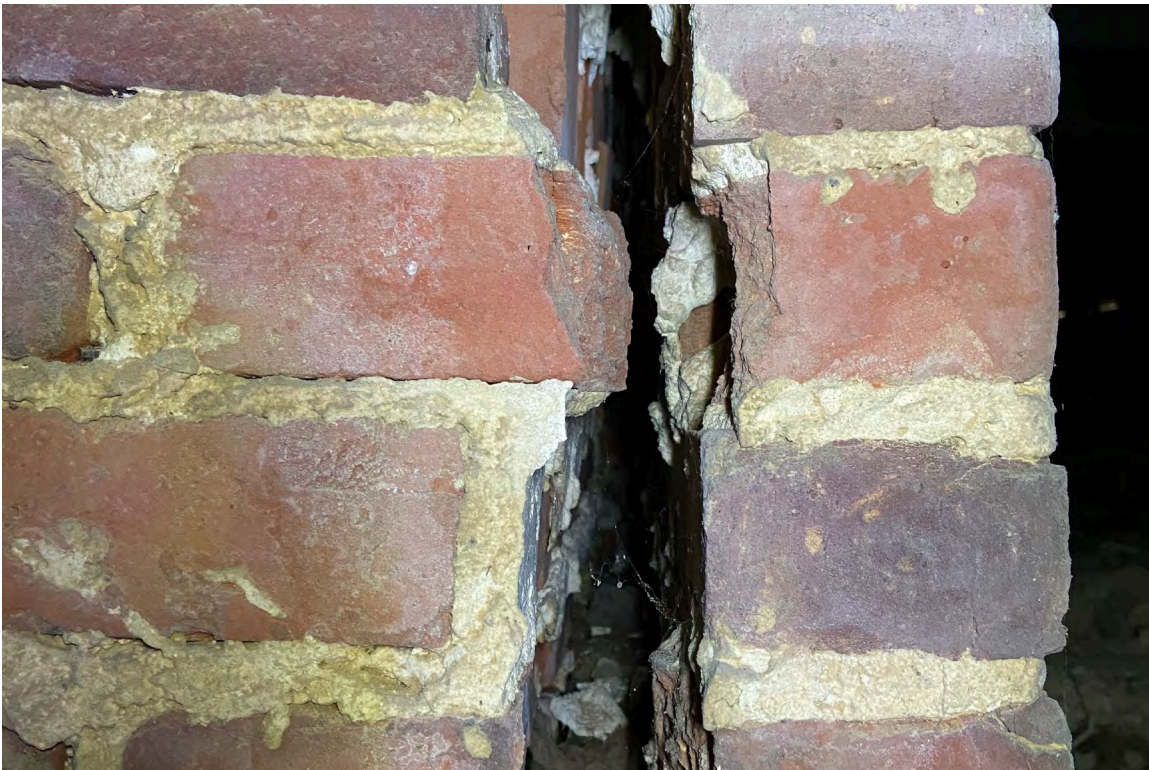
Figure 4: Epps-McGill Farmhouse - PHASE 01: Detail of crack in fireplace foundation (Kalen McNabb 2020).

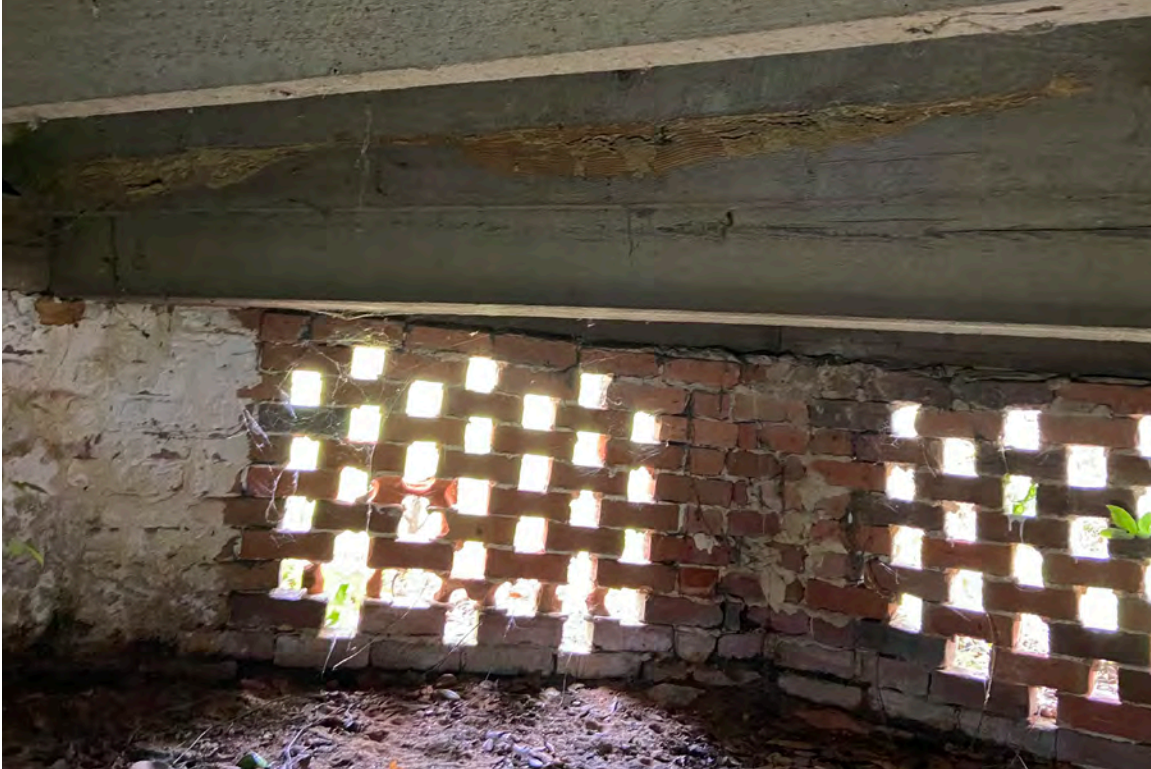
Figure 5: Epps-McGill Farmhouse - PHASE 01: Select areas of the foundation require repointing (Kalen McNabb 2020).

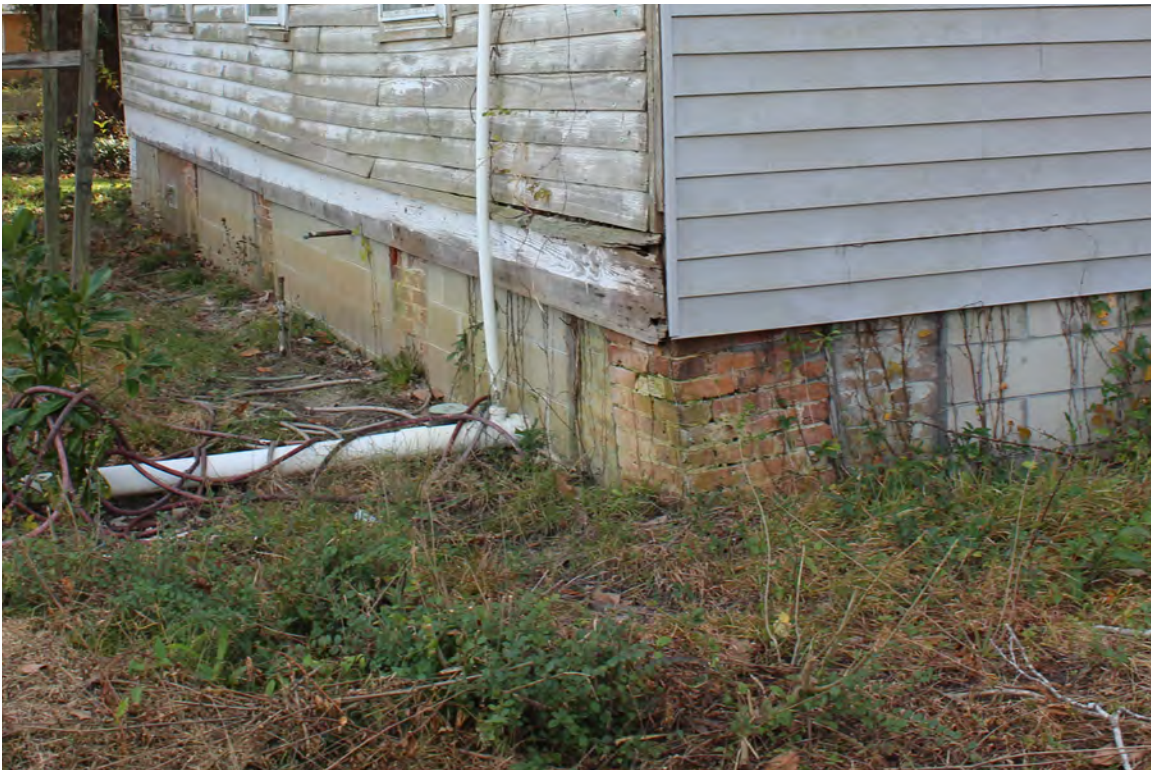
Figure 6: Epps-McGill Farmhouse - PHASE 01: Detail of deteriorated foundation masonry (Kalen McNabb 2020).

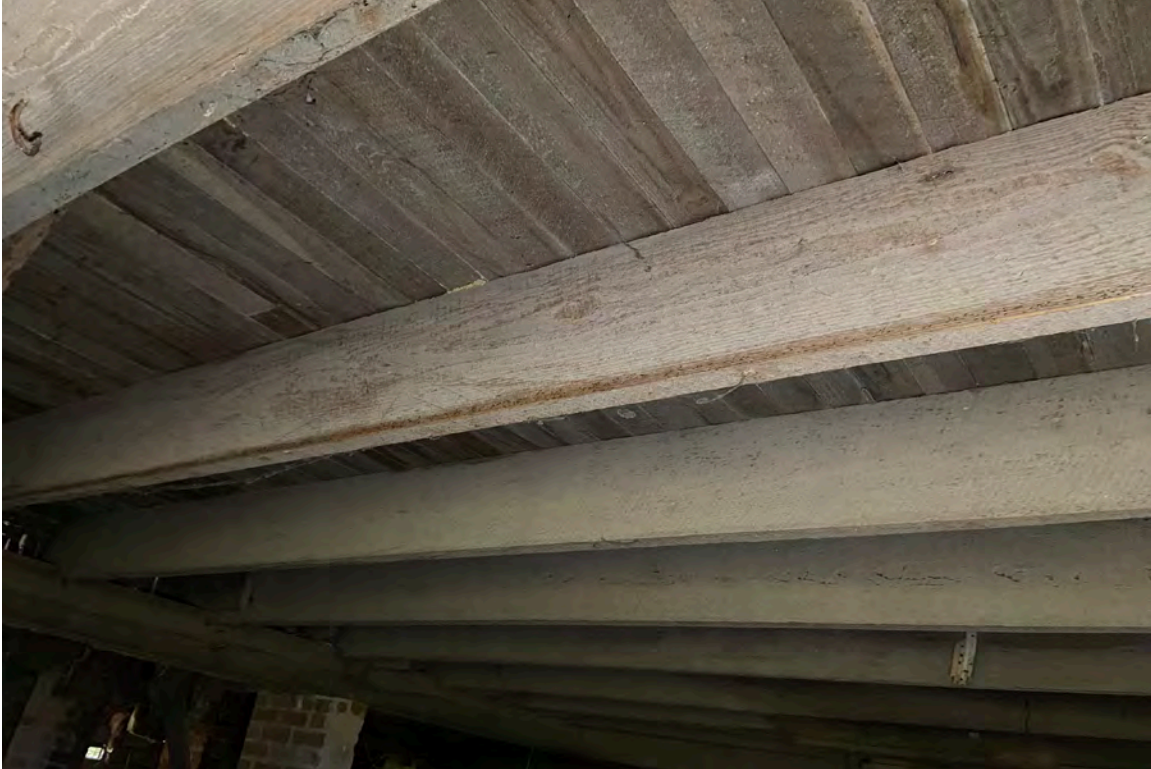
Figure 7: Epps-McGill Farmhouse - PHASE 01: The historic joists are in good condition with isolated areas of failure requiring intervention (Kalen McNabb 2020).

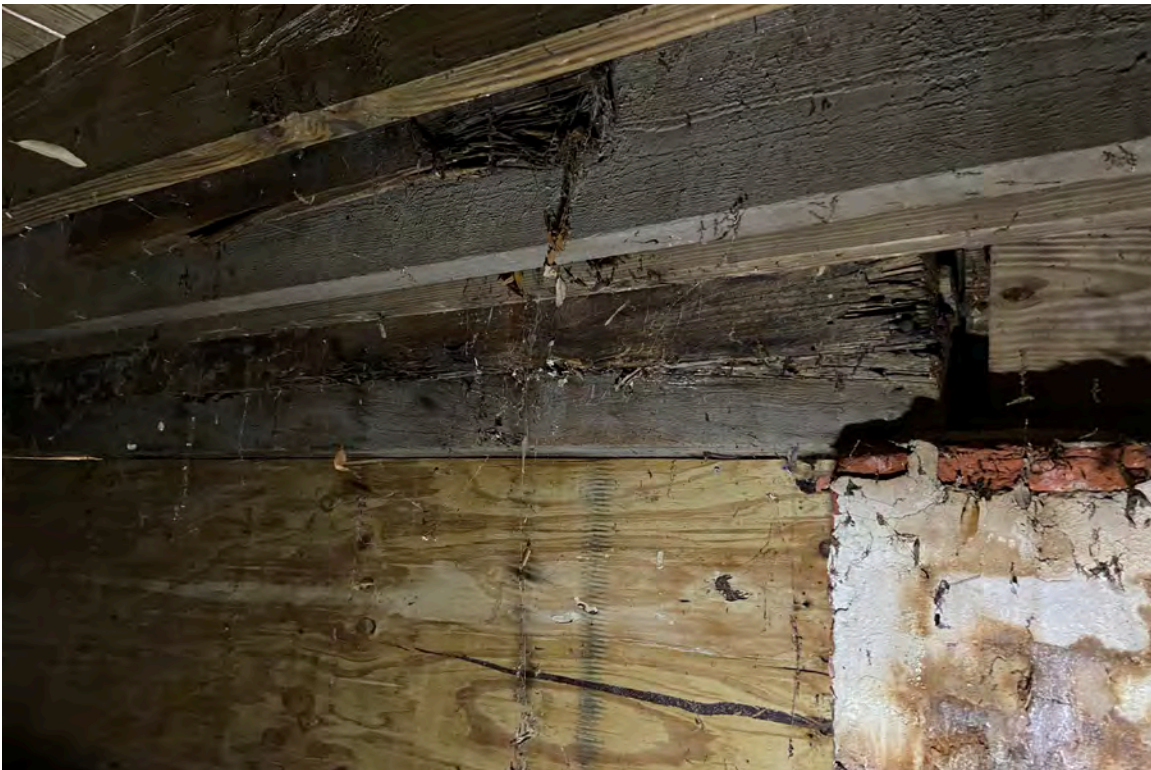
Figure 8: Epps-McGill Farmhouse - PHASE 01: Detail of deterioration along the north wall (Kalen McNabb 2020).

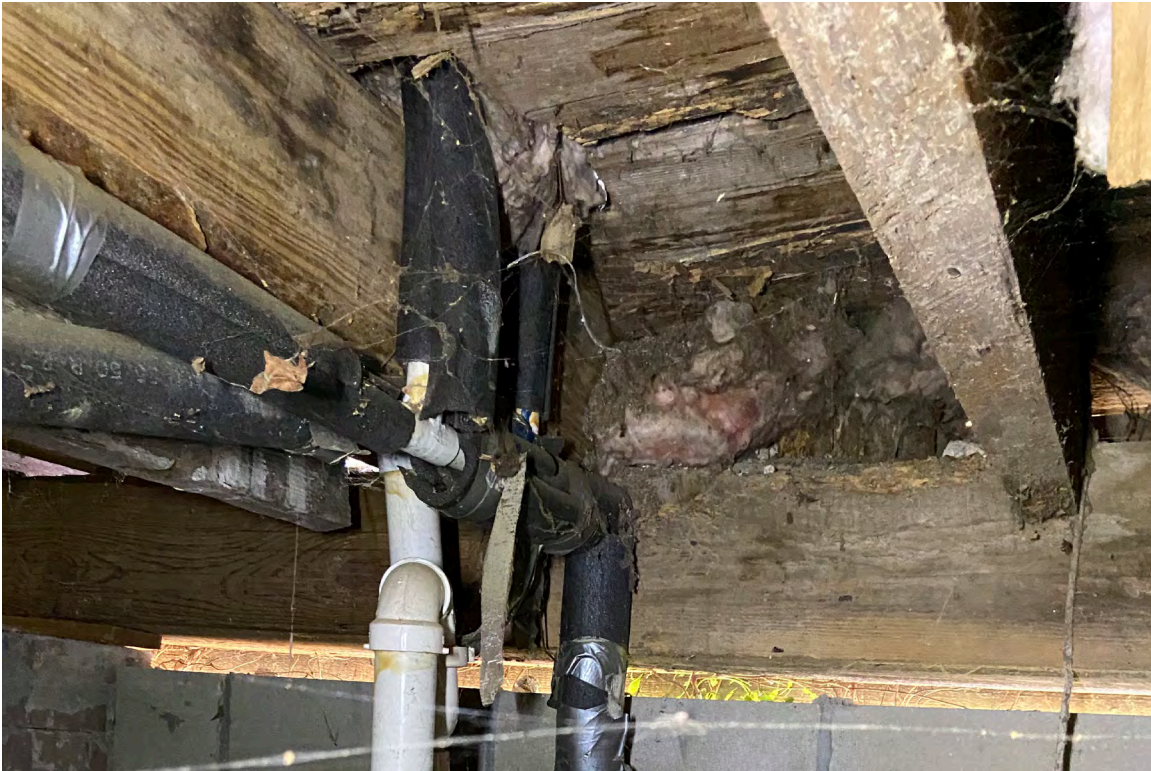
Figure 9: Epps-McGill Farmhouse - PHASE 01: Detail of framing deterioration beneath the first-floor bathrooms (Kalen McNabb 2020).

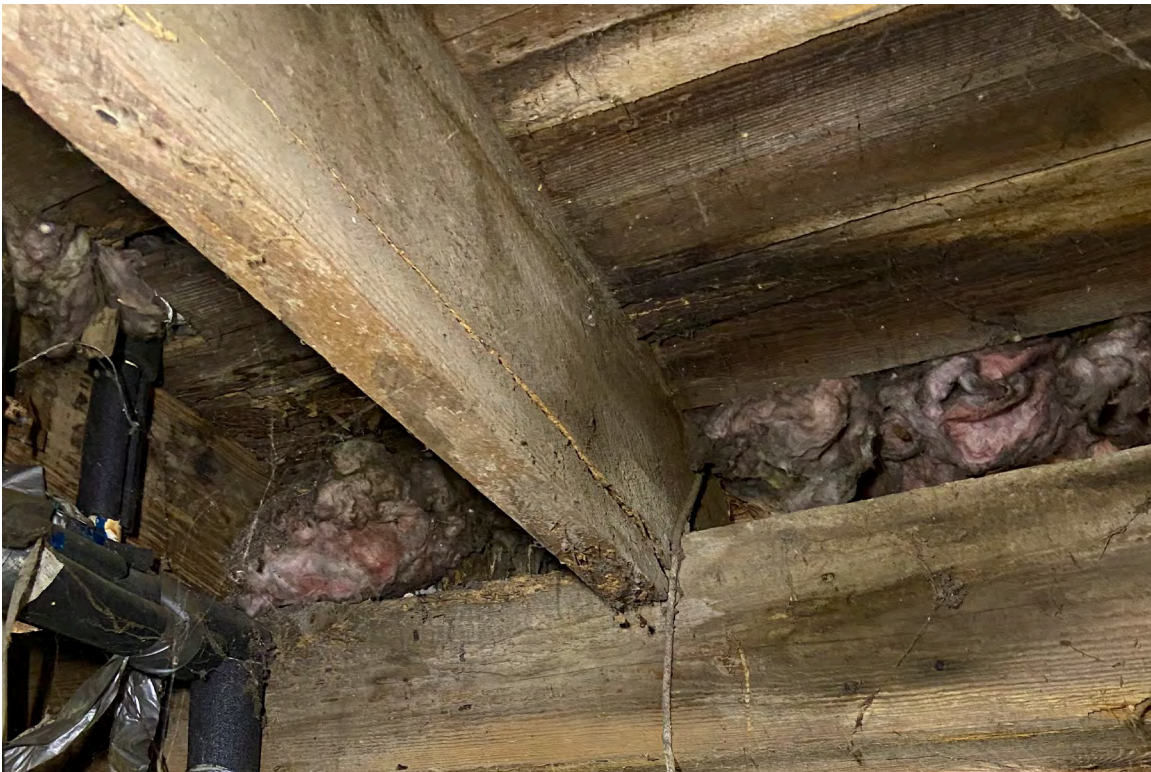
Figure 10: Epps-McGill Farmhouse - PHASE 01: Detail of joist cracking and termite damage (Kalen McNabb 2020).

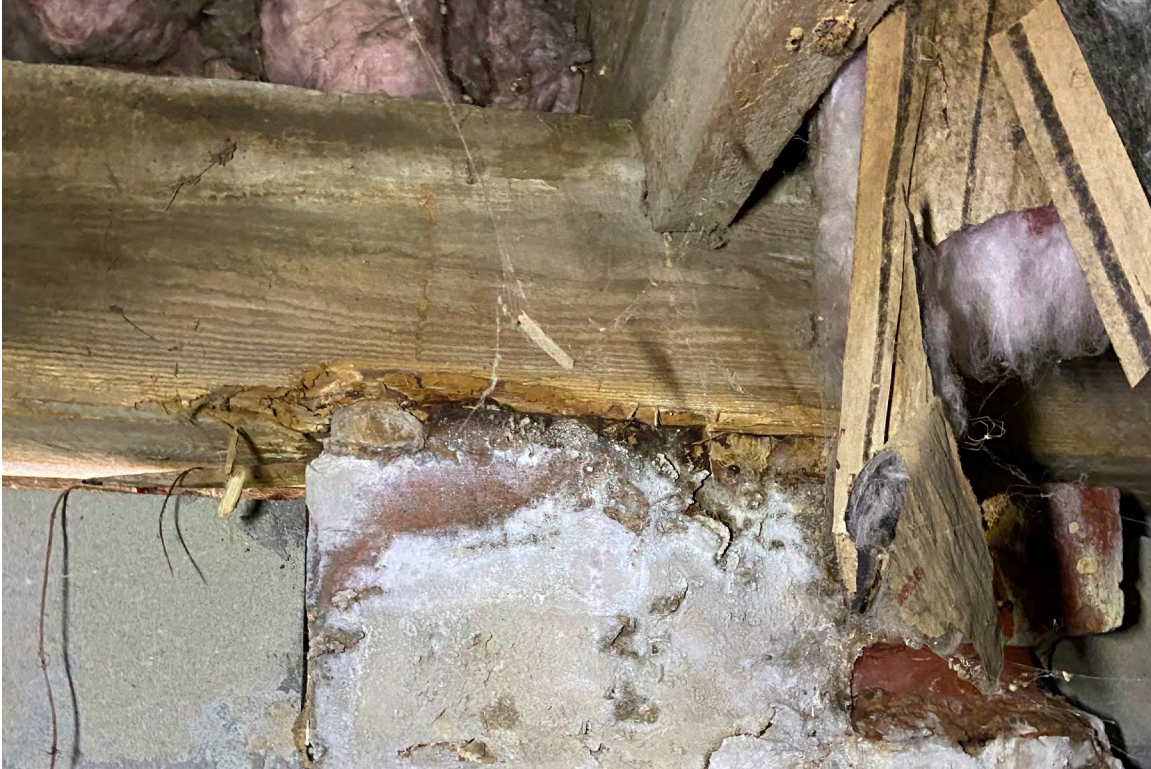
Figure 11: Epps-McGill Farmhouse - PHASE 01: Select girders are crushed and require repair (Kalen McNabb 2020).

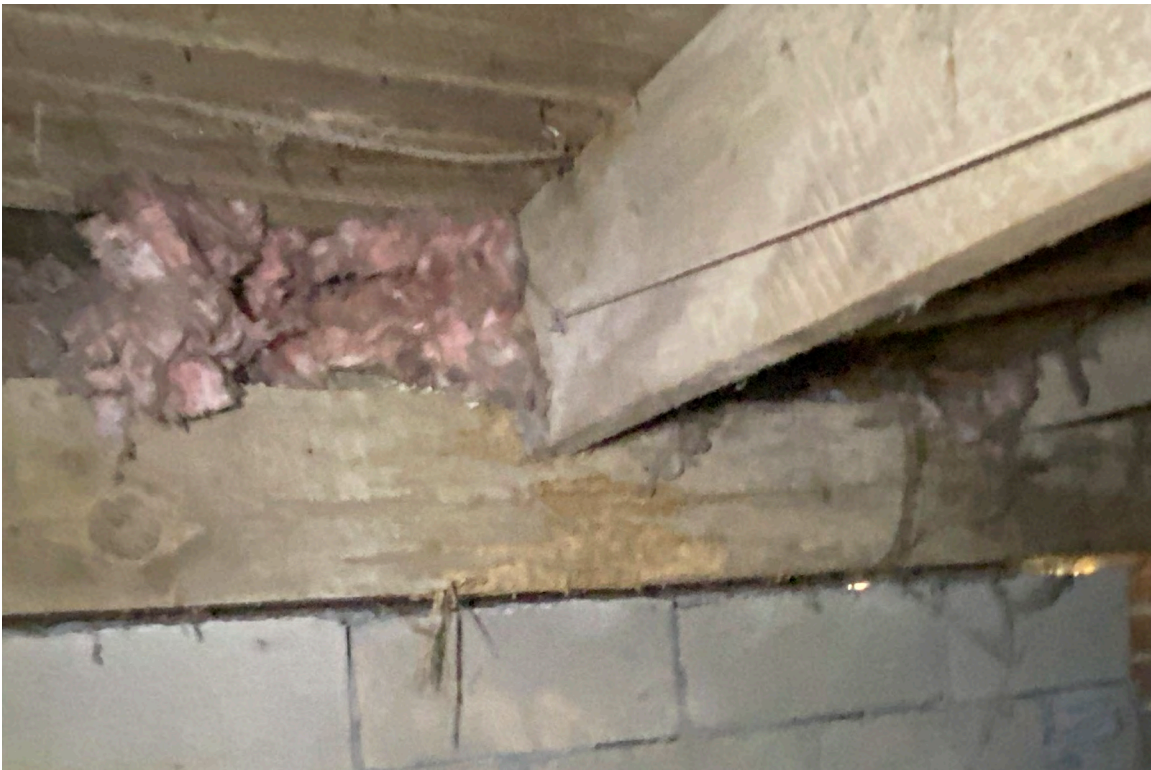
Figure 12: Epps-McGill Farmhouse - PHASE 01: Detail of deterioration within the north girder (Kalen McNabb 2020).

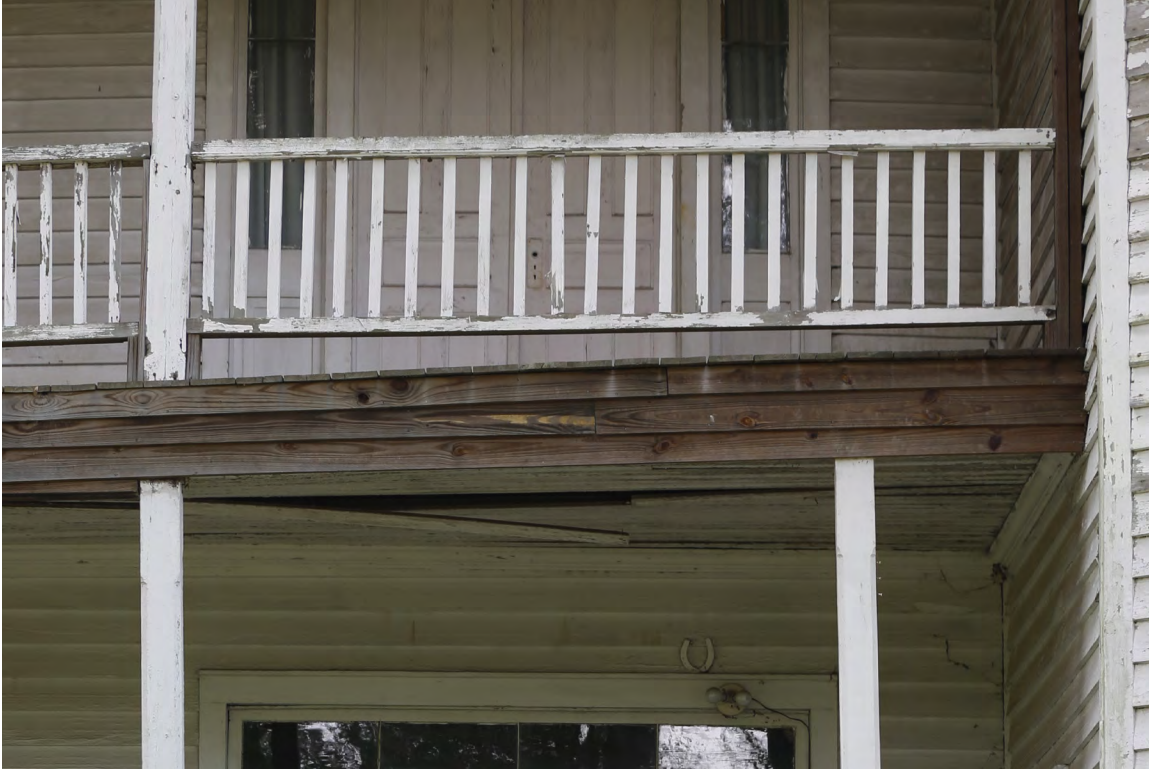
Figure 15: Epps-McGill Farmhouse - PHASE 01: Detail of Porch Railing Failure (Kalen McNabb 2020).

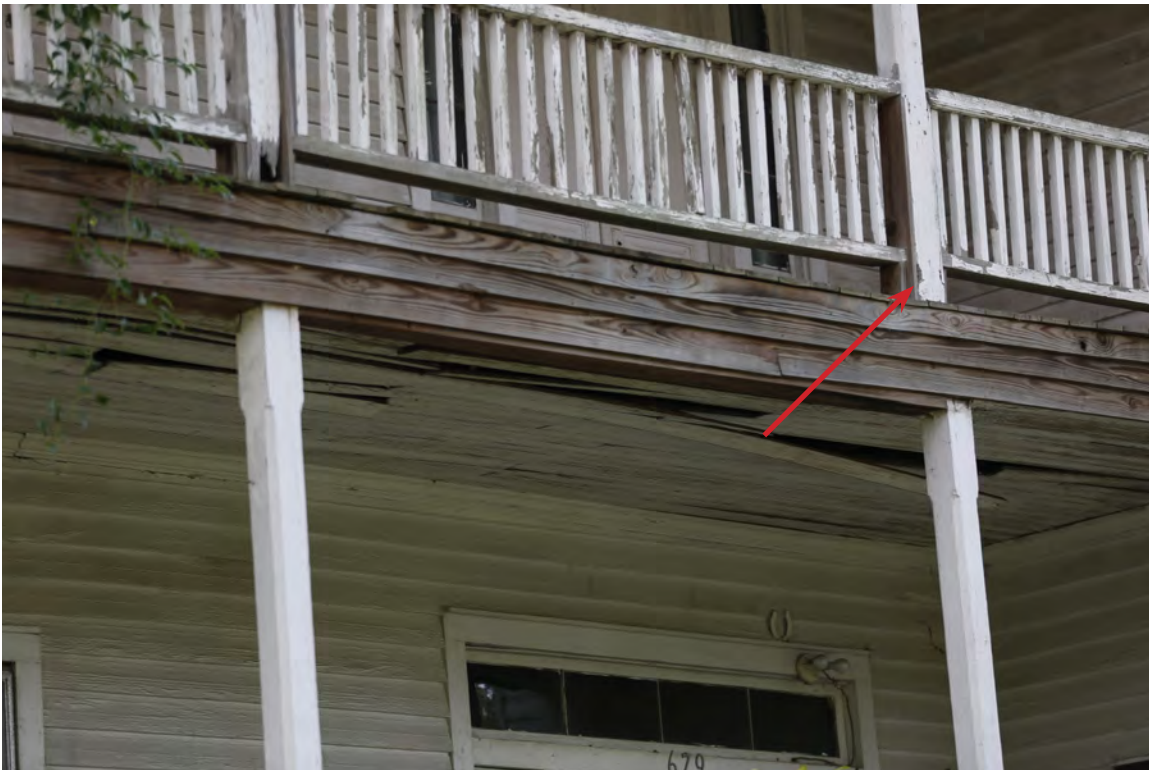
Figure 16: Epps-McGill Farmhouse - PHASE 01: This column and balustrade will be replaced in-kind during Phase 01 due to advanced deterioration (Kalen McNabb 2020).

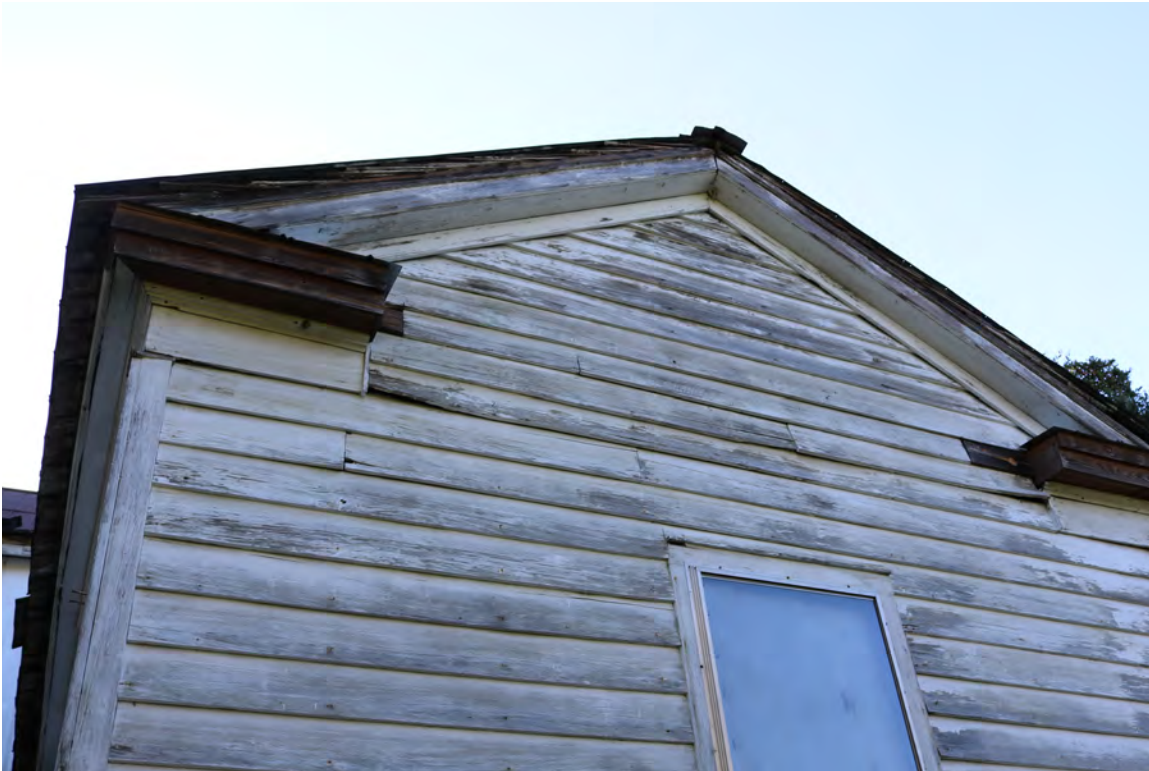
Figure 17: Epps-McGill Farmhouse - PHASE 01: The cornice has localized areas of wood deterioration and extensive paint loss on all cornice elements (Kalen McNabb 2020).

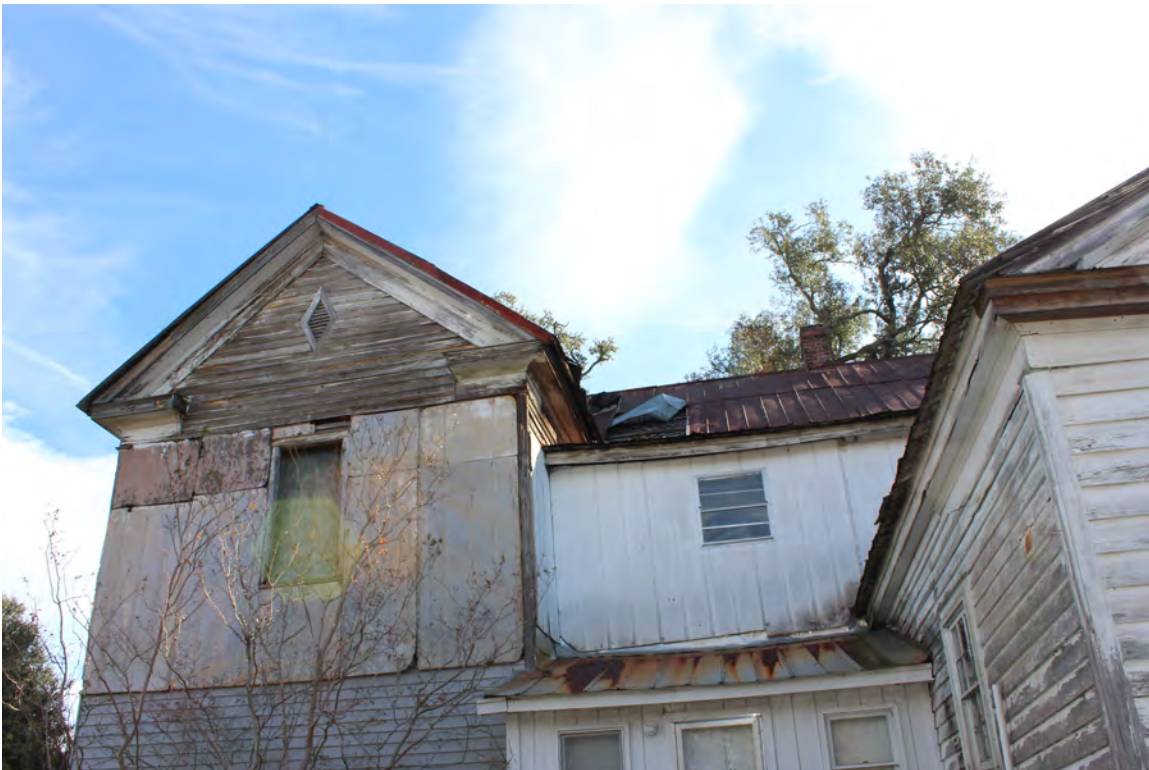
Figure 18: Epps-McGill Farmhouse - PHASE 01: Overview of cornice deterioration (Kalen McNabb 2020).

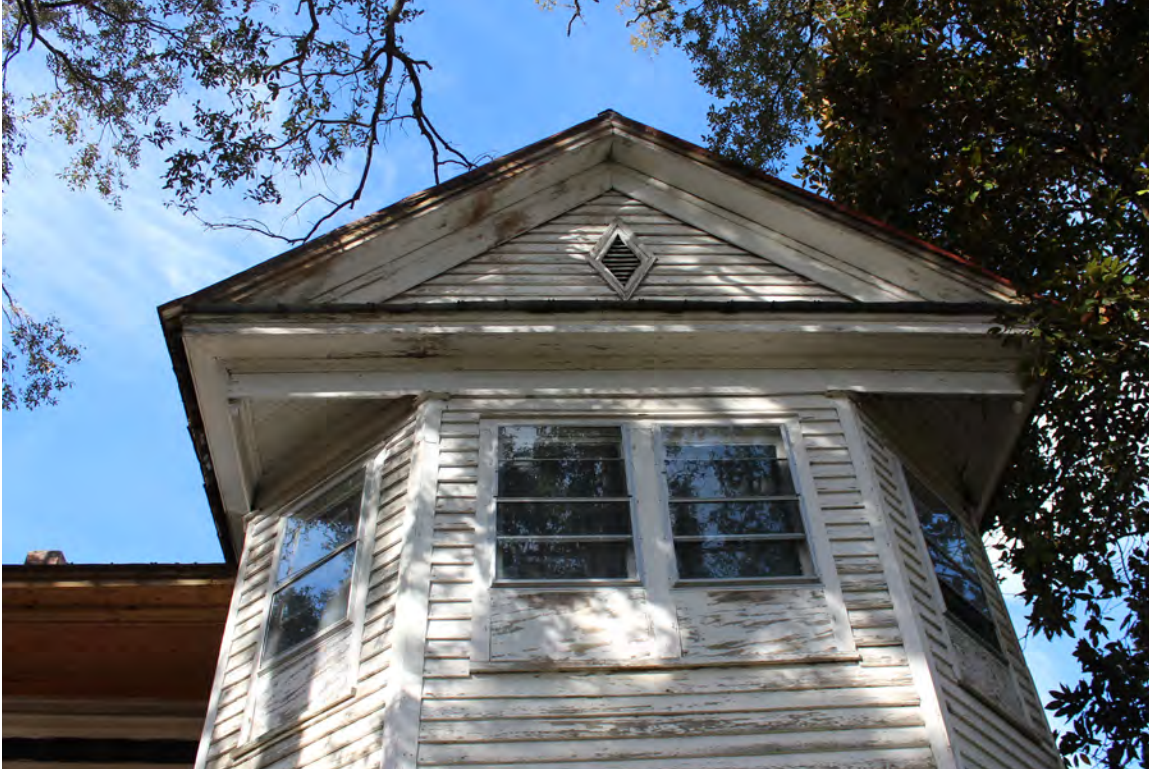
Figure 19: Epps-McGill Farmhouse - PHASE 01: Detail of cornice paint failure on the front facade (Kalen McNabb 2020).

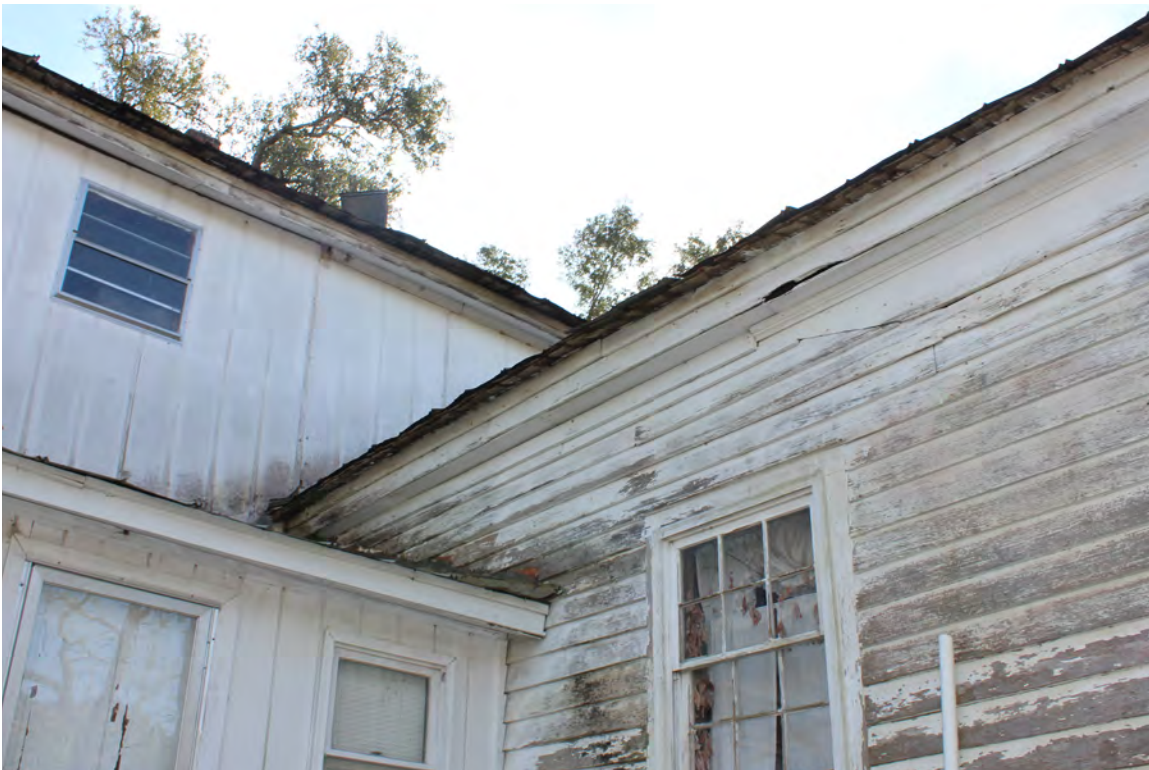
Figure 20: Epps-McGill Farmhouse - PHASE 01: Detail of cornice failure (Kalen McNabb 2020).

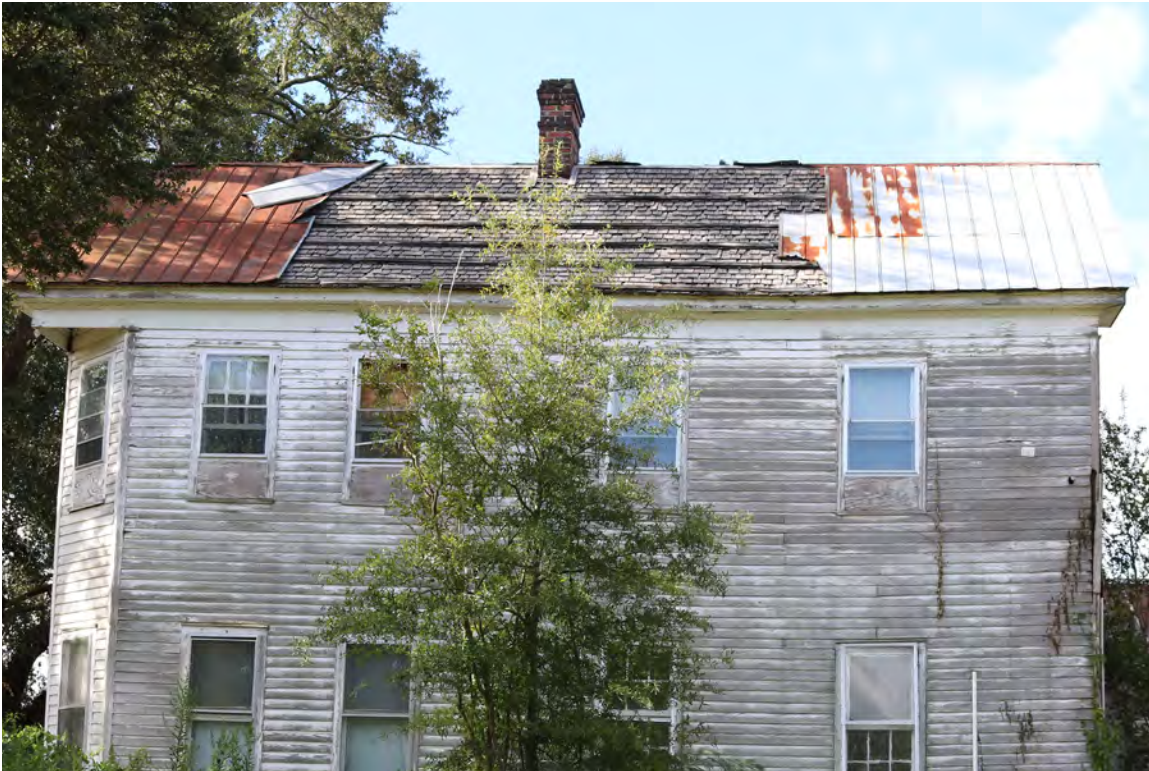
Figure 21: Epps-McGill Farmhouse - PHASE 01: The existing 5V metal roof is heavily corroded and missing on 30-40% of the roof. (Kalen McNabb 2020).

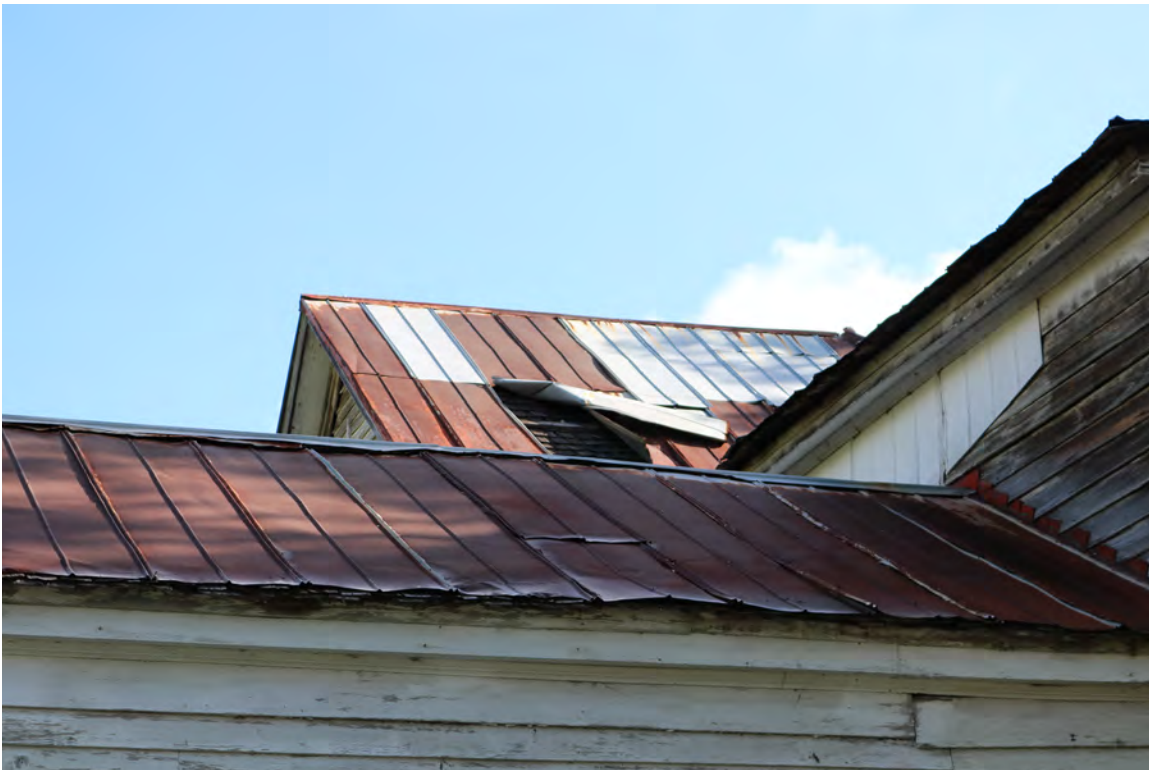
Figure 22: Epps-McGill Farmhouse - PHASE 01: Many of the metal roofing panels are detaching (Kalen McNabb 2020).

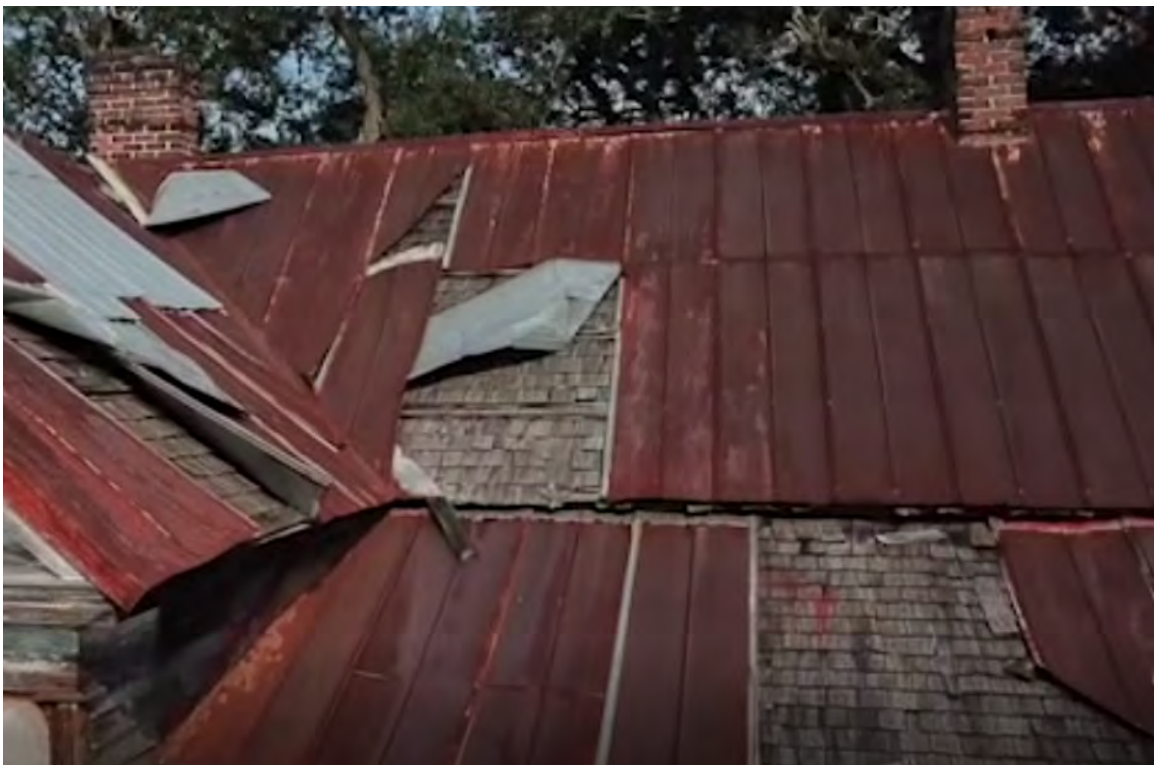
Figure 24: Epps-McGill Farmhouse - PHASE 01: The failure of the upper roof has exposed the underlying weathered wood shake roof. The house is no longer watertight (Kalen McNabb 2020).

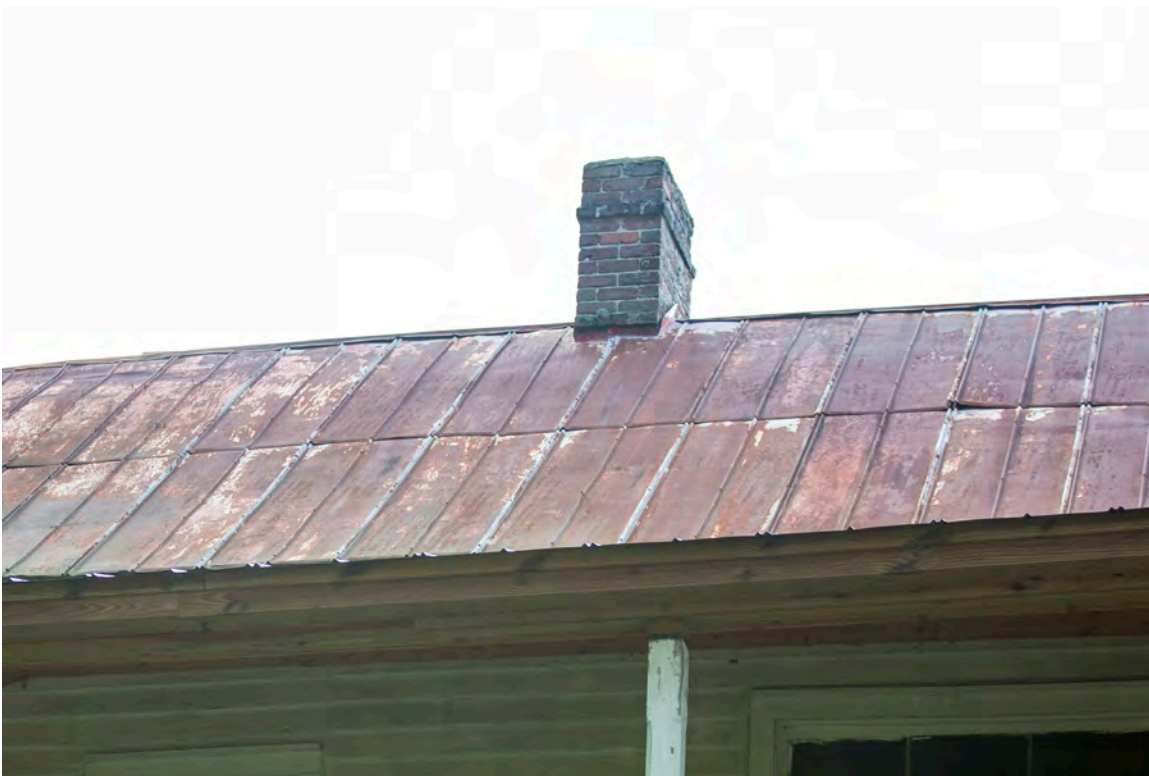
Figure 25: Epps-McGill Farmhouse - PHASE 01: The chimneys are in fair condition but likely require repointing (Kalen McNabb 2020).

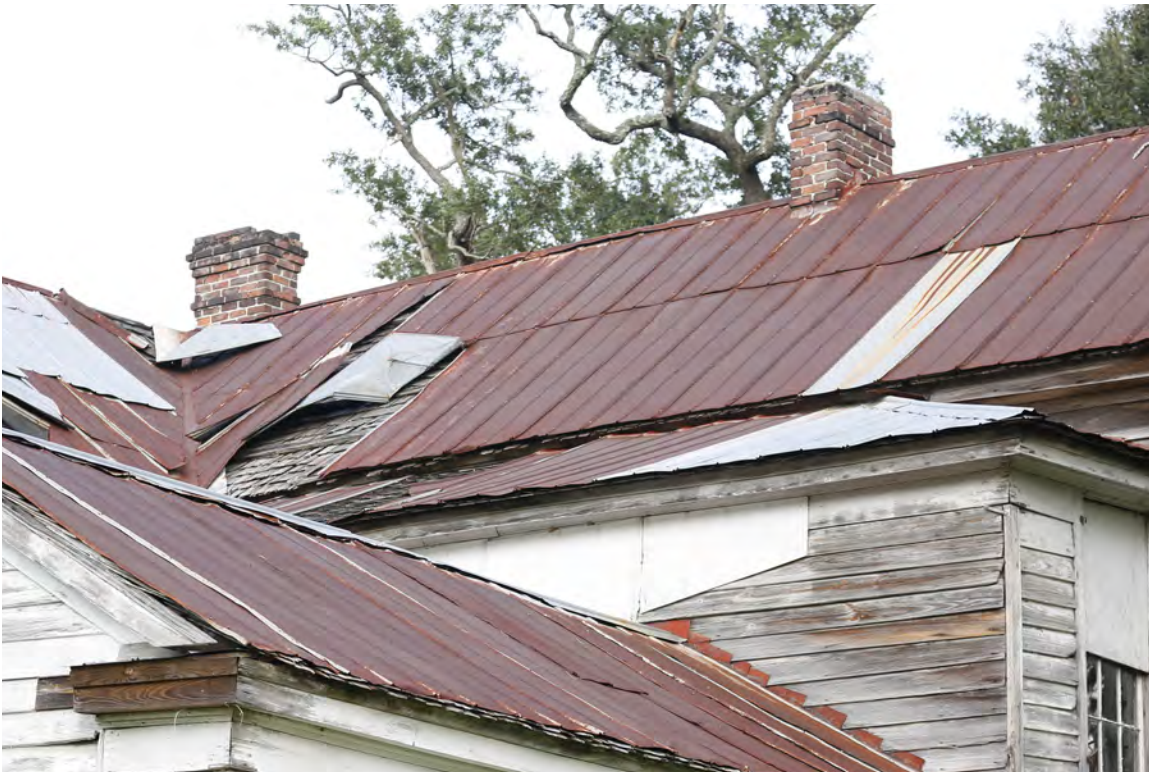
Figure 26: Epps-McGill Farmhouse - PHASE 01: Overview of chimneys viewed from the south (Kalen McNabb 2020).
