PROJECT MANUAL APPENDIX EPPS-MCGILL FARMHOUSE

MEADORS, Inc.

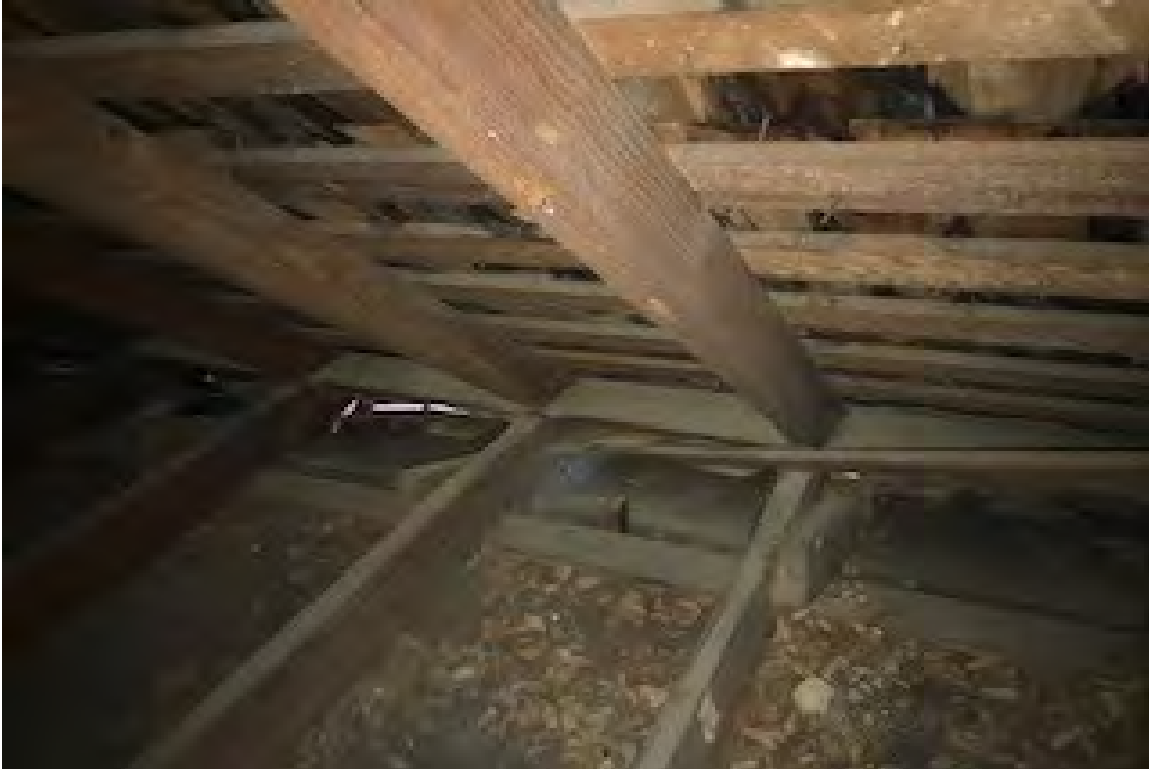
Figure 27: Epps-McGill Farmhouse - PHASE 01: The attic framing is in fair condition but the wooden framing members are undersized and over-spanned (Kalen McNabb 2020).

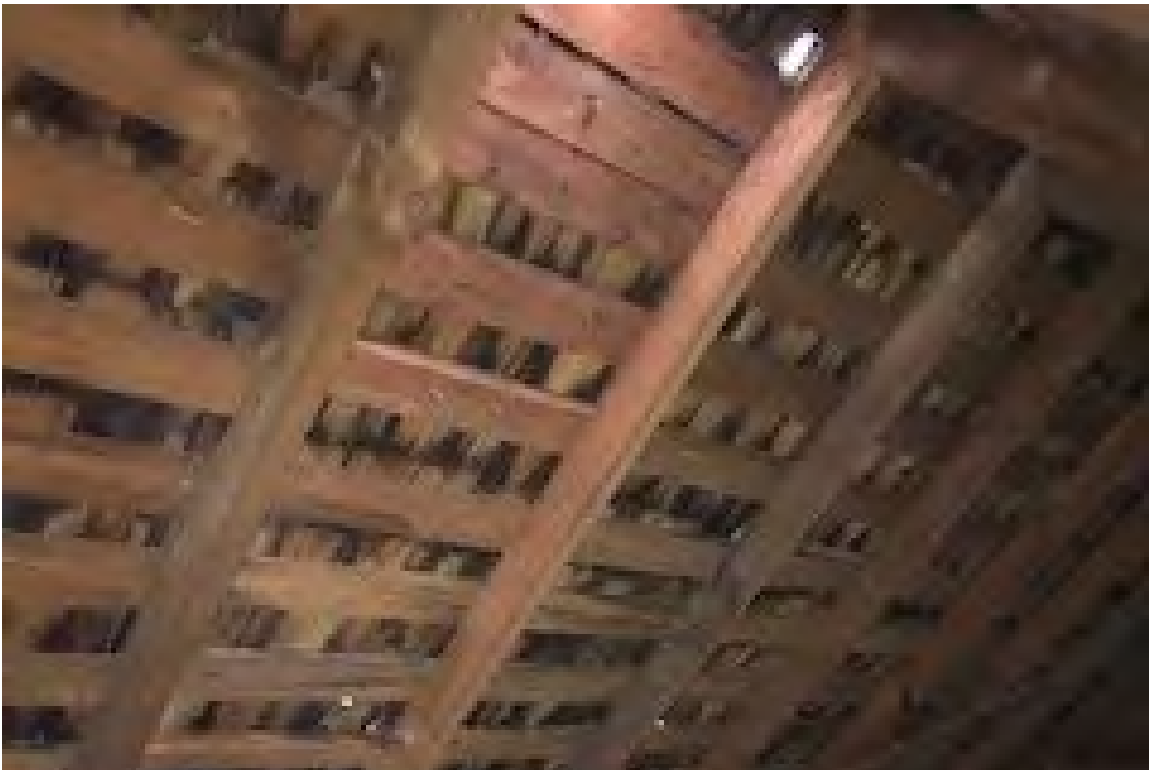
Figure 28: Epps-McGill Farmhouse - PHASE 01: The rafters are deflecting and require additional support (Kalen McNabb 2020).

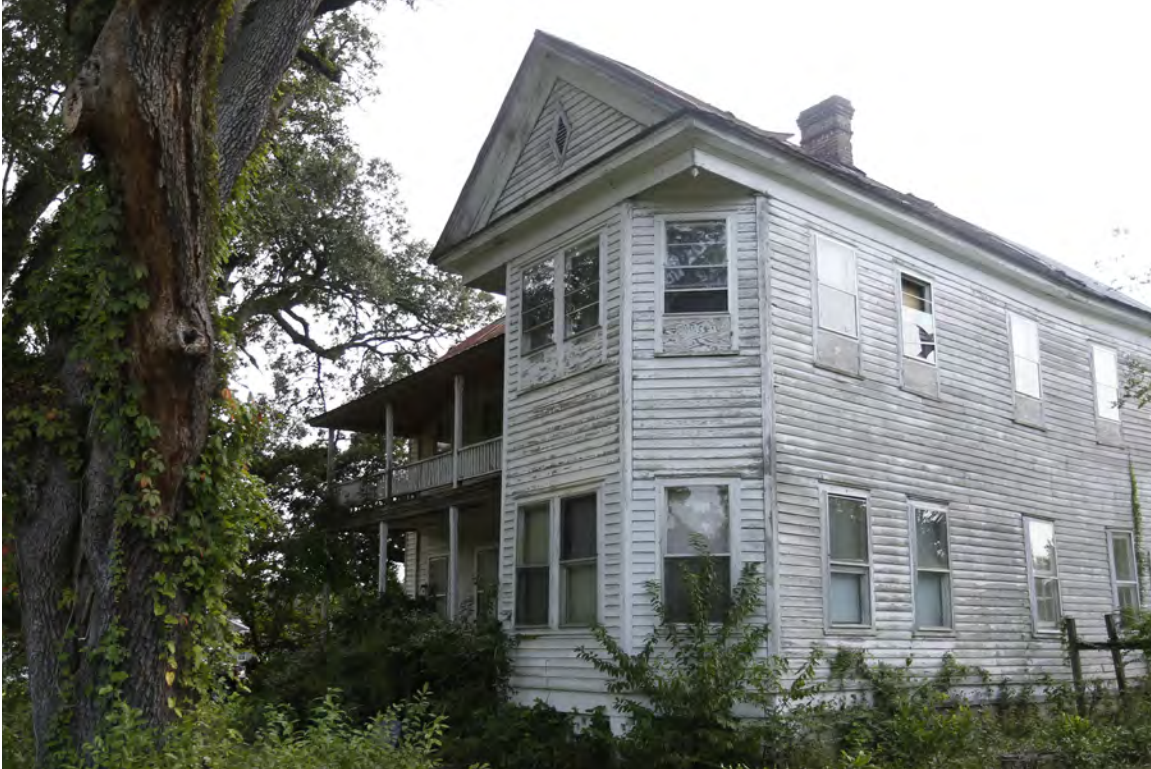
Figure 33: Epps-McGill Farmhouse - PHASE 02: The historic siding remains in place on 75% of the building and appears to be in fair condition (Kalen McNabb 2020).

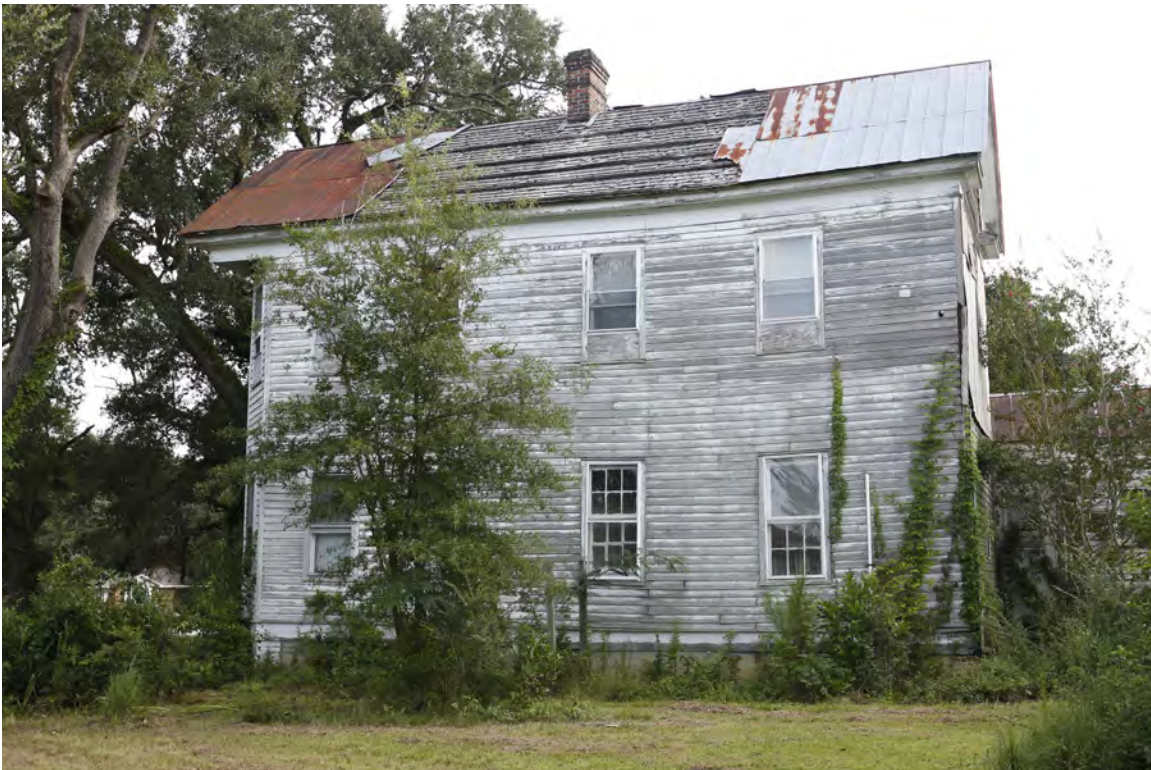
Figure 34: Epps-McGill Farmhouse - PHASE 02: Overview of historic siding on the north elevation (Kalen McNabb 2020).

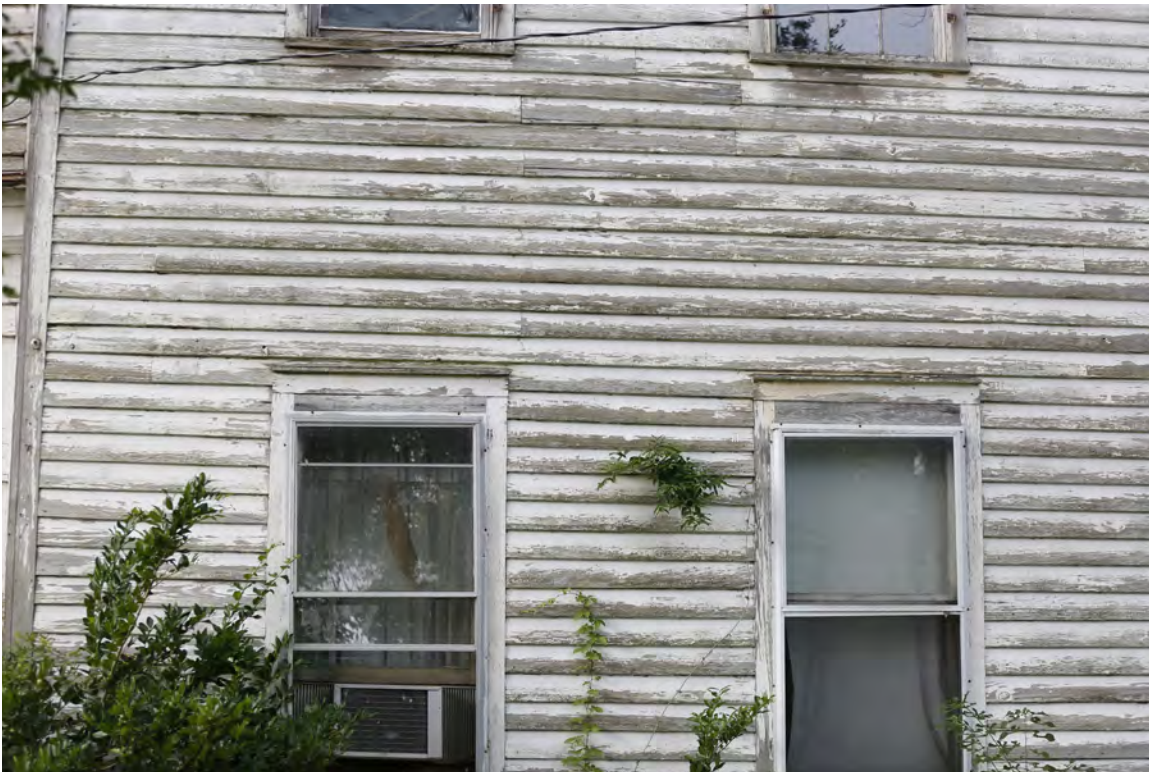
Figure 36: Epps-McGill Farmhouse - PHASE 02: Detail of the typical condition of the historic siding and trim (Kalen McNabb 2020).

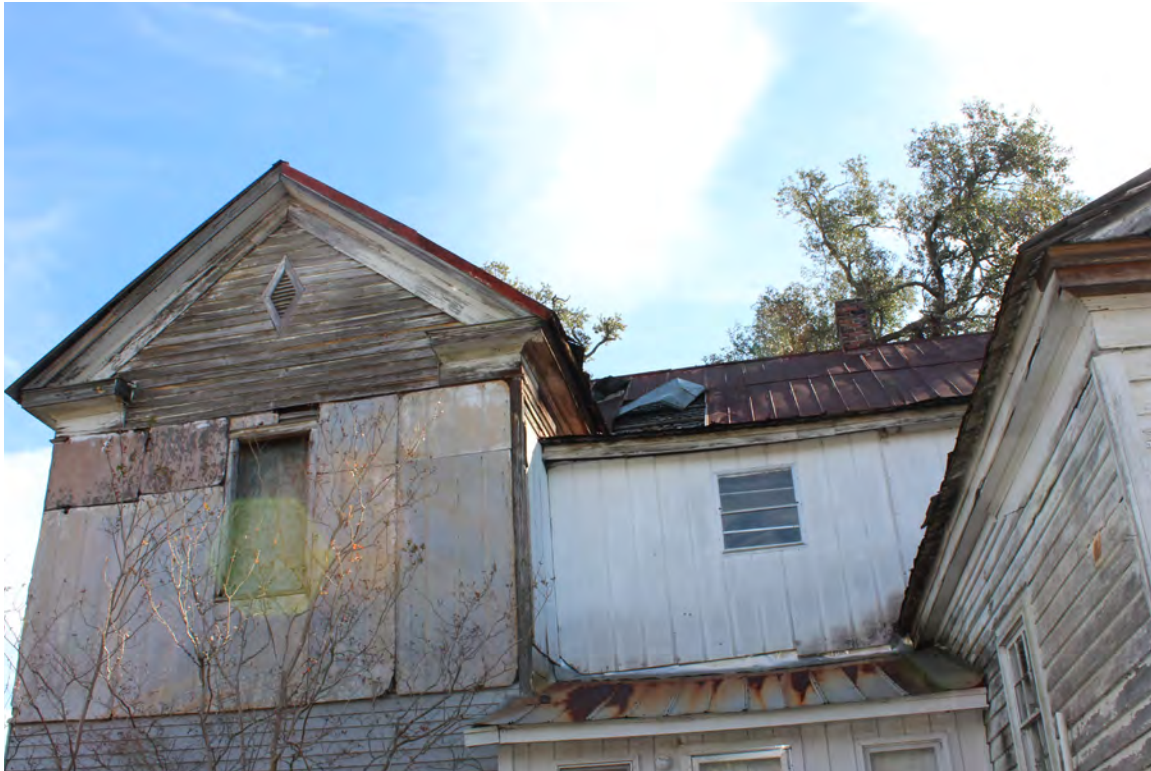
Figure 37: Epps-McGill Farmhouse - PHASE 02: Overview of the mixture of siding materials on the west elevation (Kalen McNabb 2020).

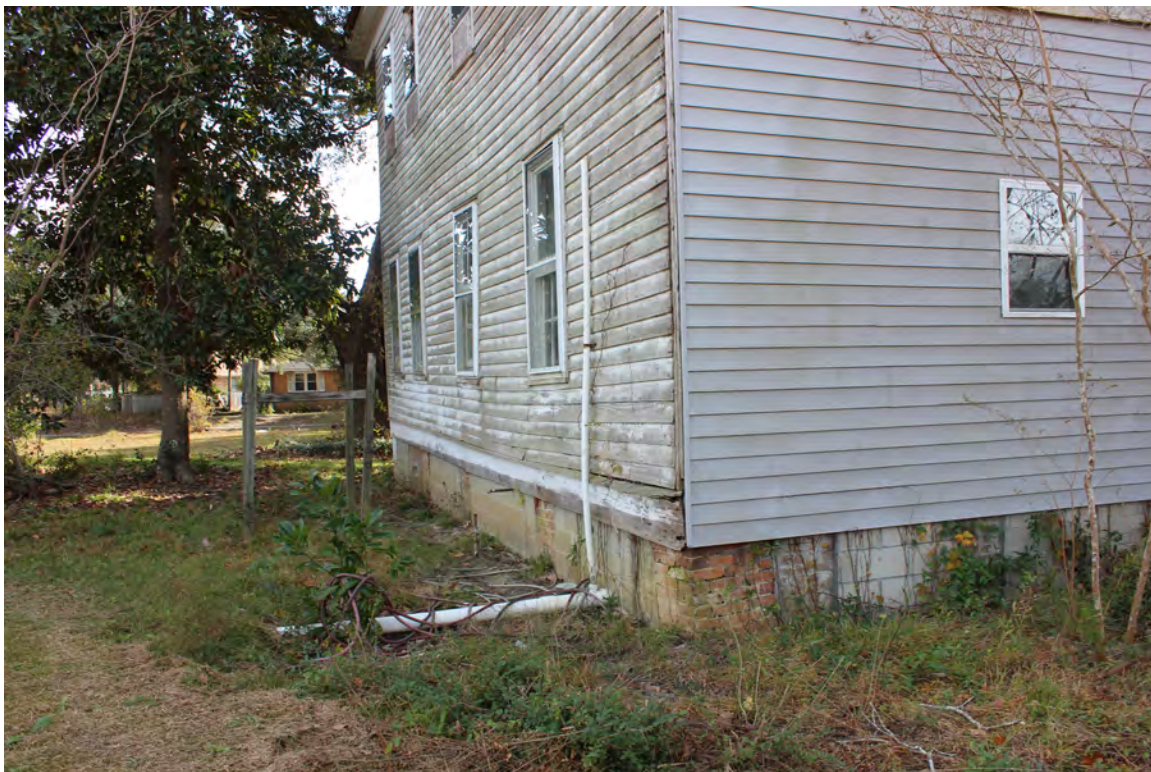
Figure 38: Epps-McGill Farmhouse - PHASE 02: There is extensive paint failure on all the historic siding. Note the vinyl siding at right (Kalen McNabb 2020).

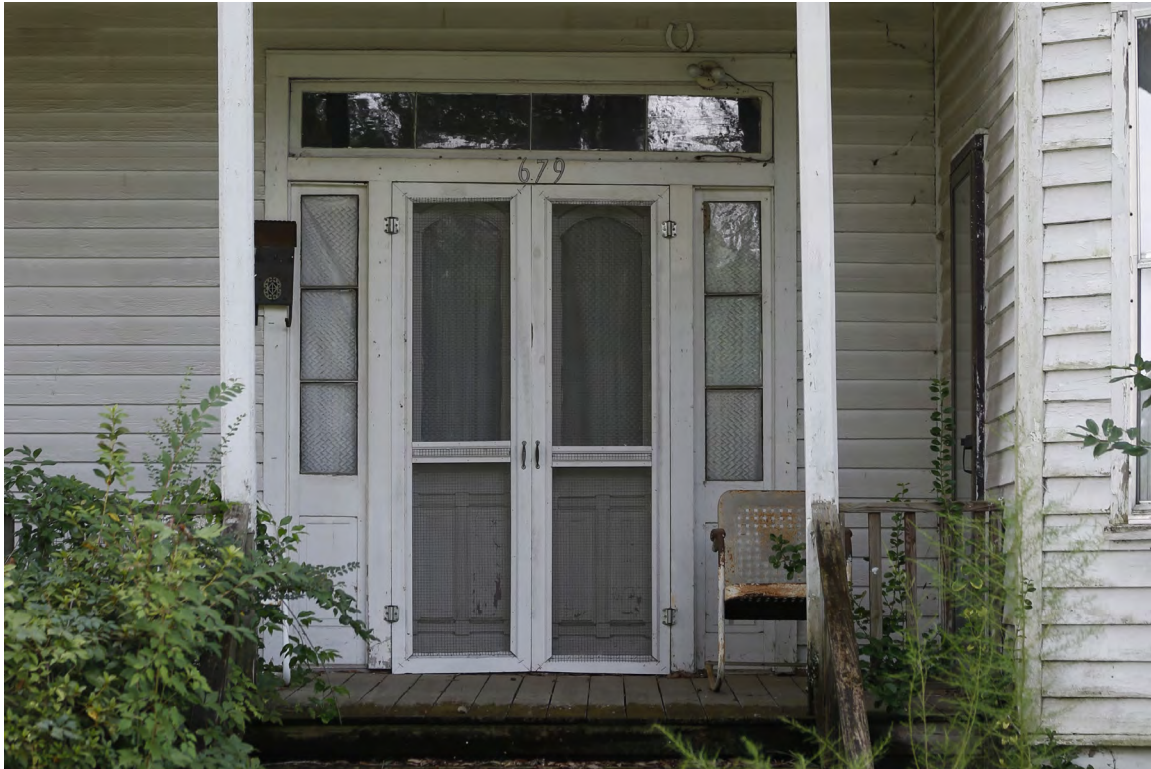
Figure 39: Epps-McGill Farmhouse - PHASE 02: The front doors are in good condition but require restoration (Kalen McNabb 2020).

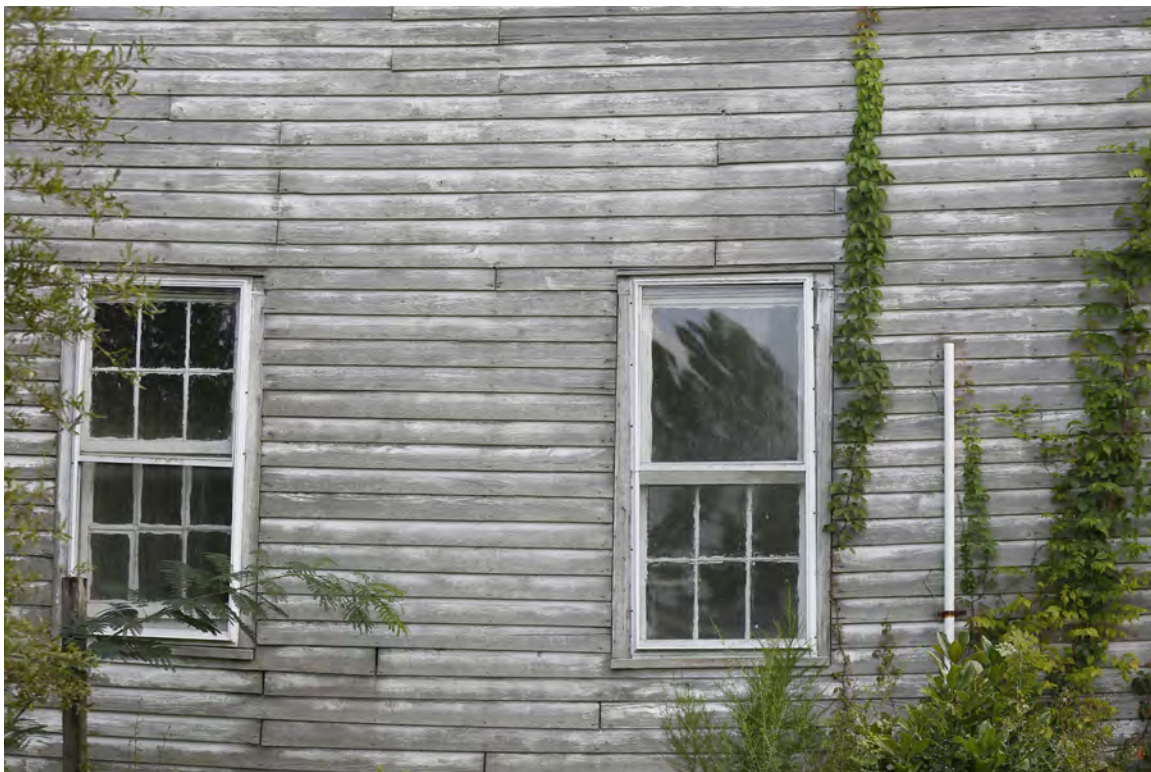
Figure 40: Epps-McGill Farmhouse - PHASE 02: The house contains a mixture of 1/1, 1/6, 6/1 and 6/6 lite double hung windows. All windows are in a state of disrepair. Physical evidence indicates the original configuration was likely 6/6 lite sashes (Kalen McNabb 2020).

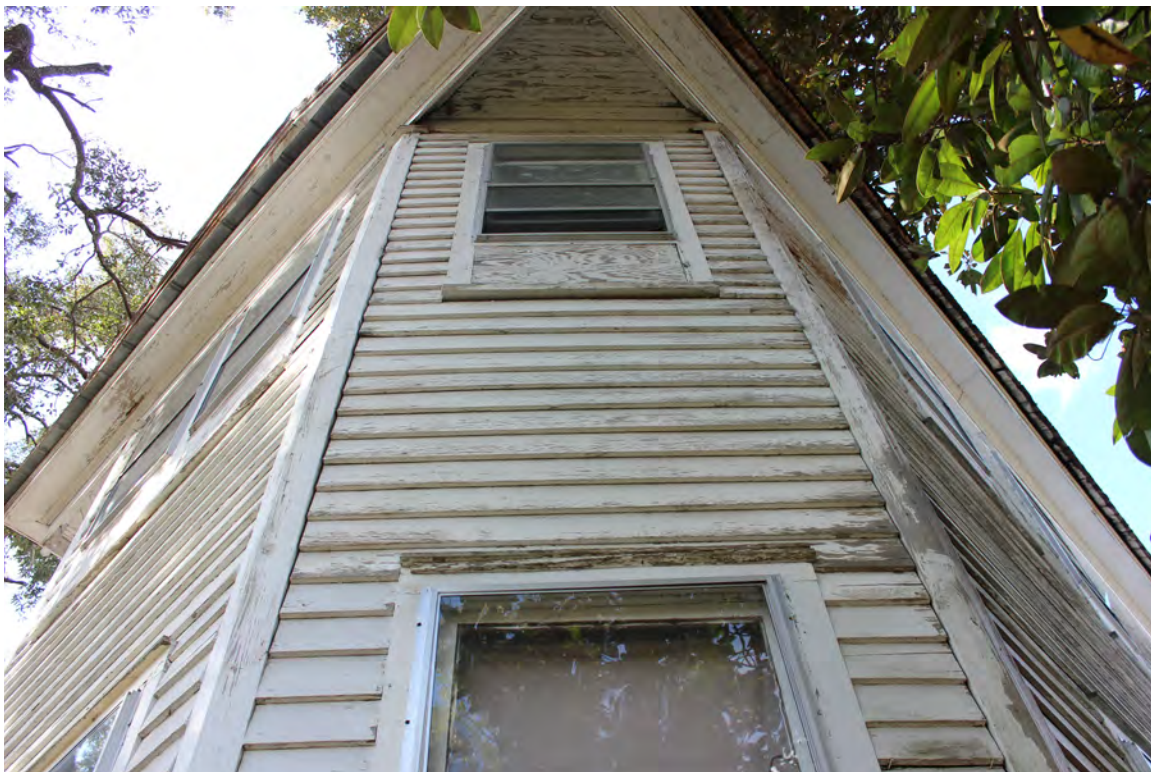
Figure 42: Epps-McGill Farmhouse - PHASE 02: Inappropriate window replacement has reduced the size of several openings and plywood has been installed to close the gap. These openings will be restored (Kalen McNabb 2020).

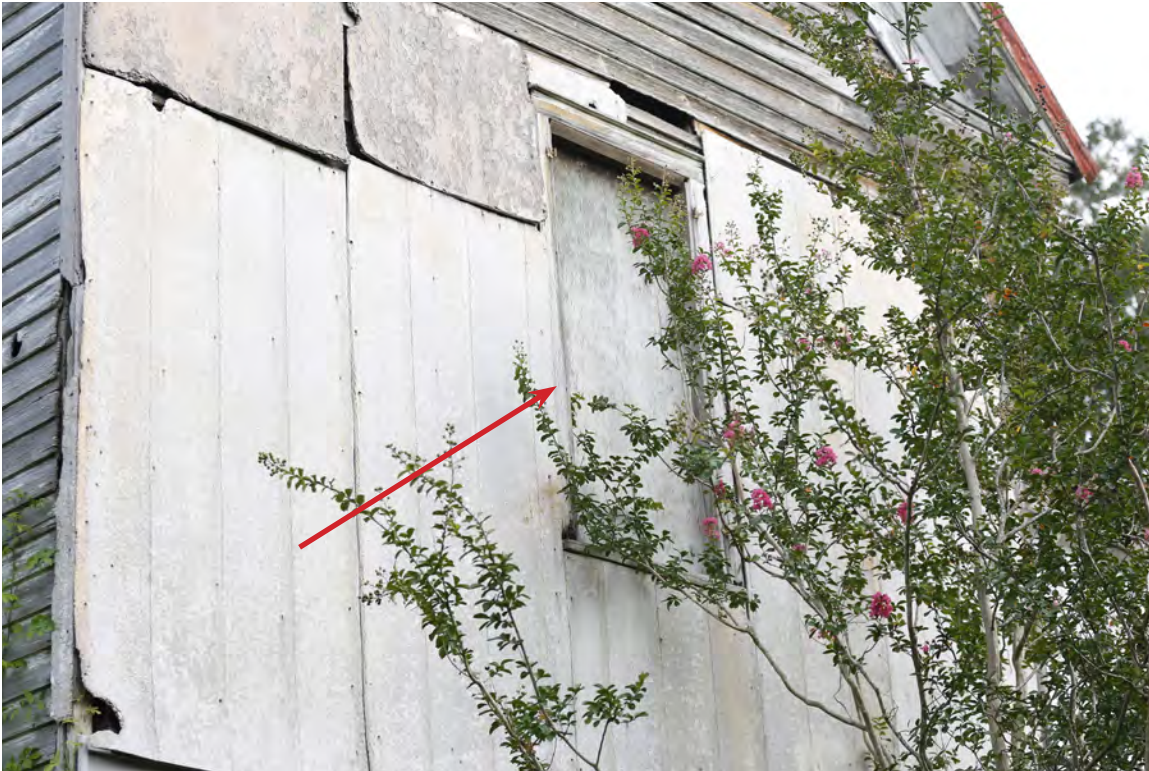
Figure 43: Epps-McGill Farmhouse - PHASE 02: Detail of missing sashes on the west elevation in a historic opening (Kalen McNabb 2020).

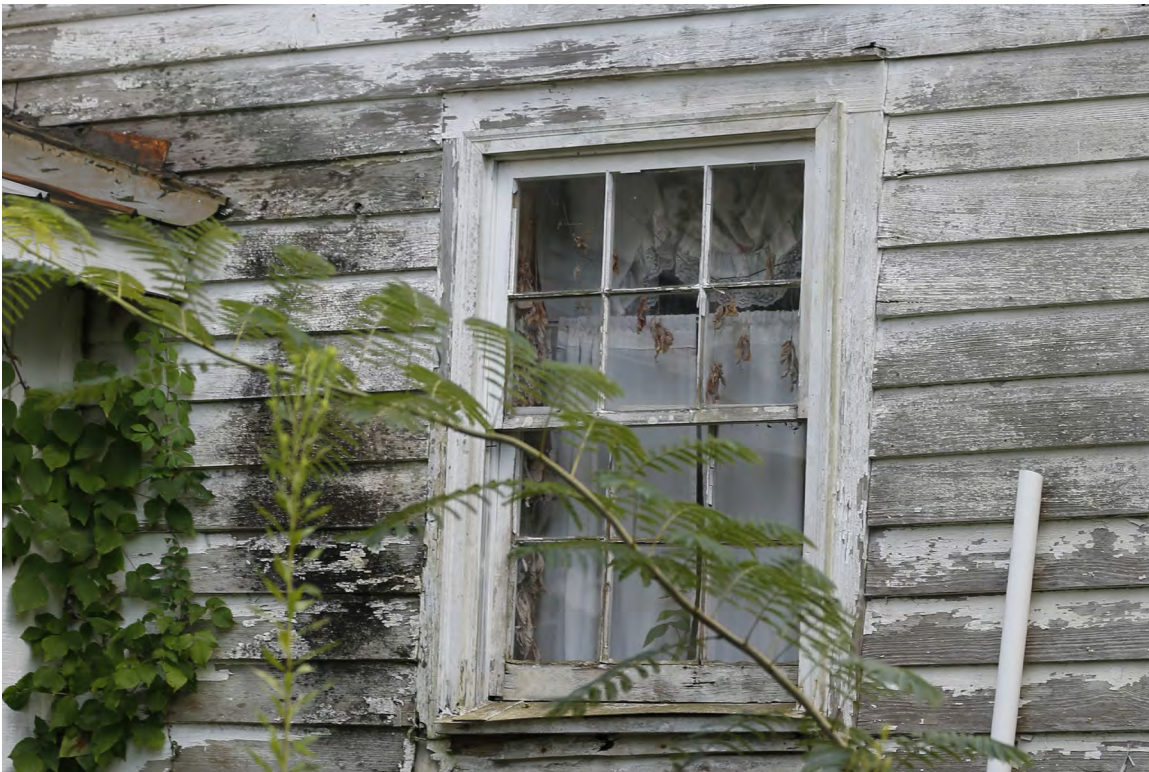
Figure 44: Epps-McGill Farmhouse - PHASE 02: Detail of north kitchen window requiring repair (Kalen McNabb 2020).

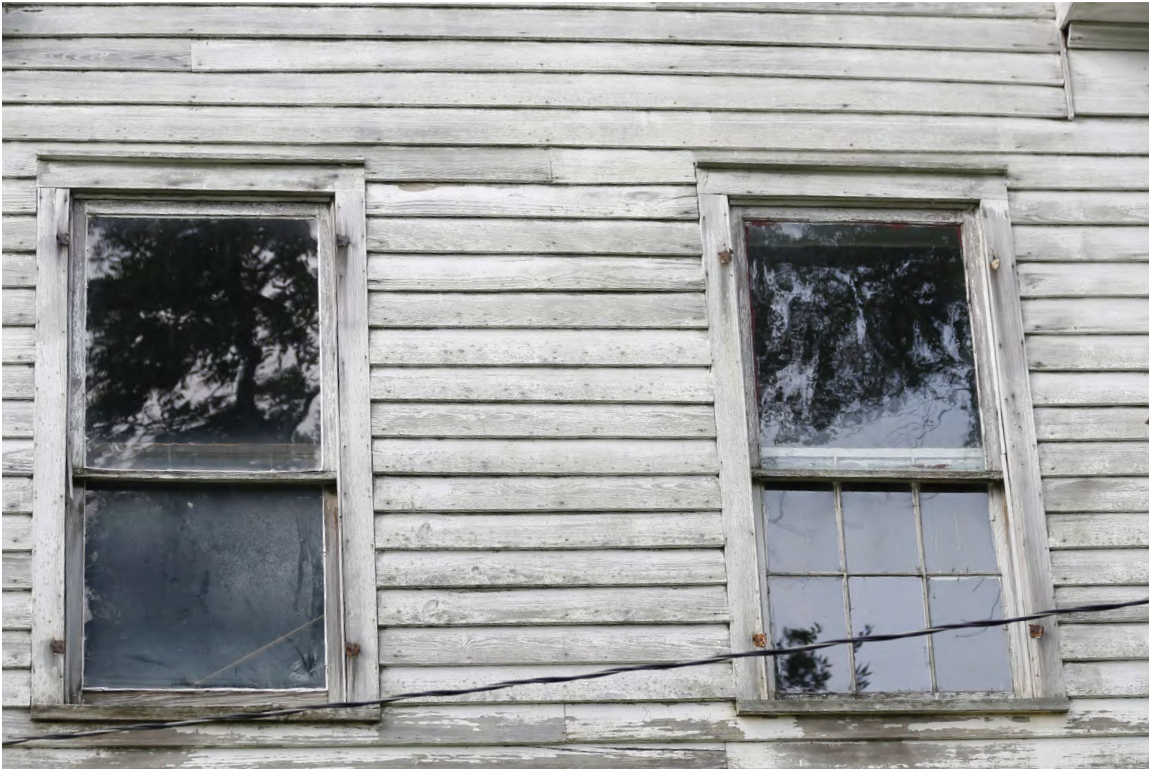
Figure 45: Epps-McGill Farmhouse - PHASE 02: View of window deterioration and haphazard replacement (Kalen McNabb 2020).

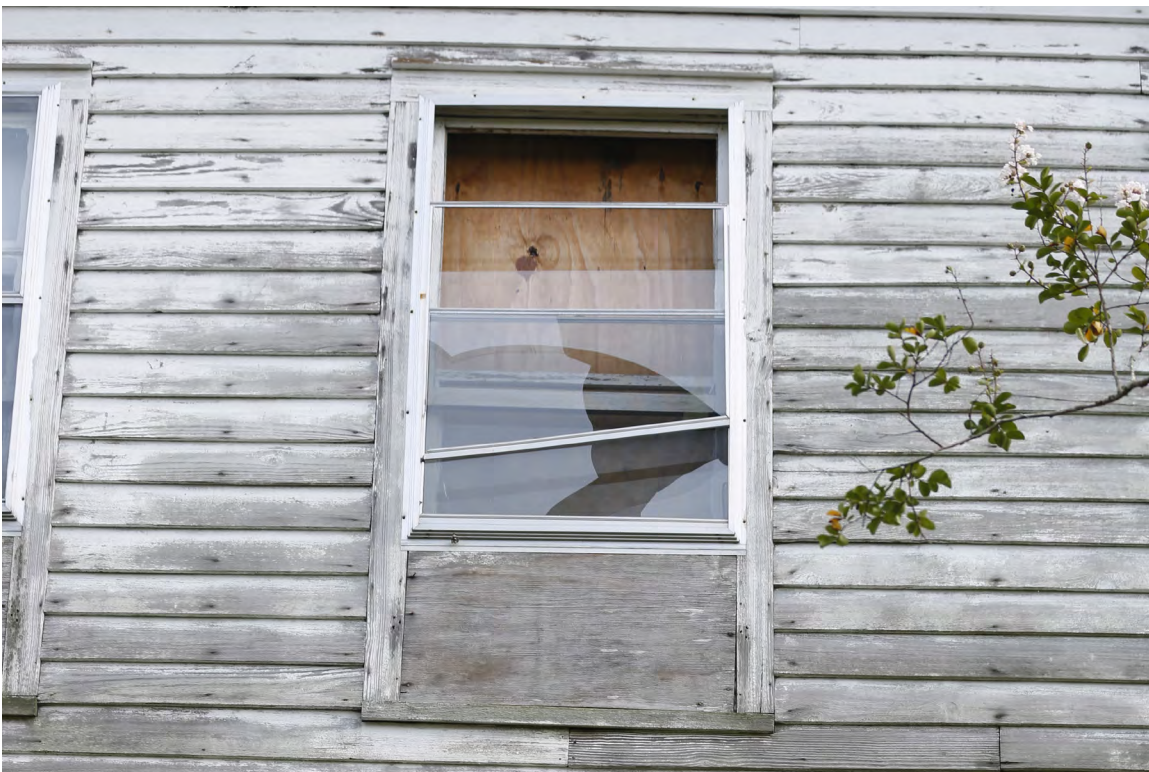
Figure 46: Epps-McGill Farmhouse - PHASE 02: Detail of broken glass and modern sashes within the original opening. New 6/6 wood sashes will be installed in the openings where missing (Kalen McNabb 2020).

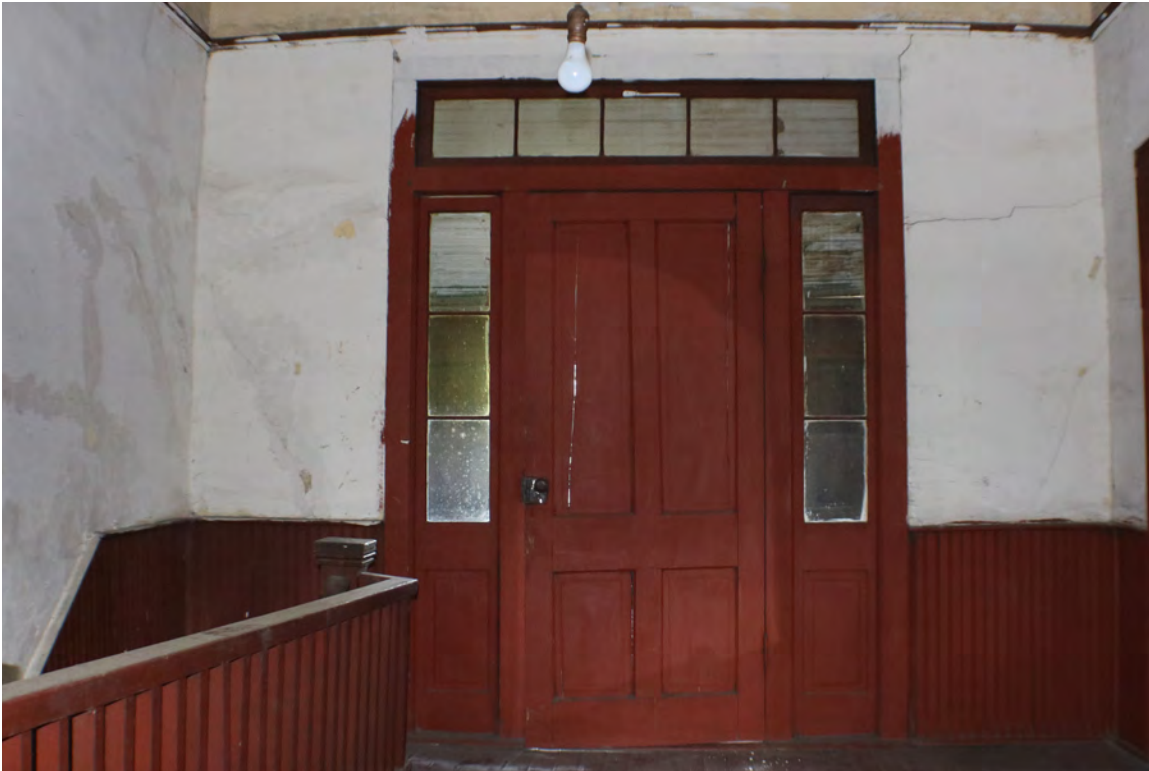
Figure 47: Epps-McGill Farmhouse - PHASE 02: View of original second-floor porch door (Kalen McNabb 2020).

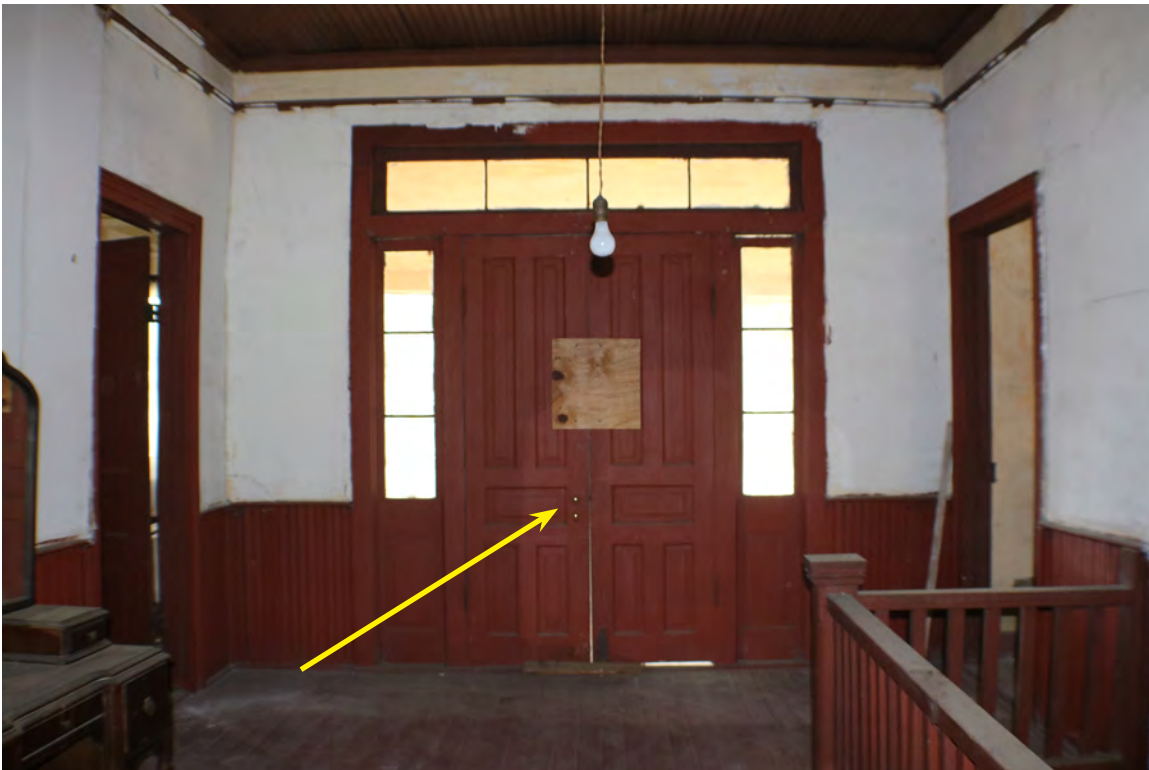
Figure 48: Epps-McGill Farmhouse - PHASE 02: Second floor east porch doors are currently secured with plywood and is missing door hardware (Kalen McNabb 2020).

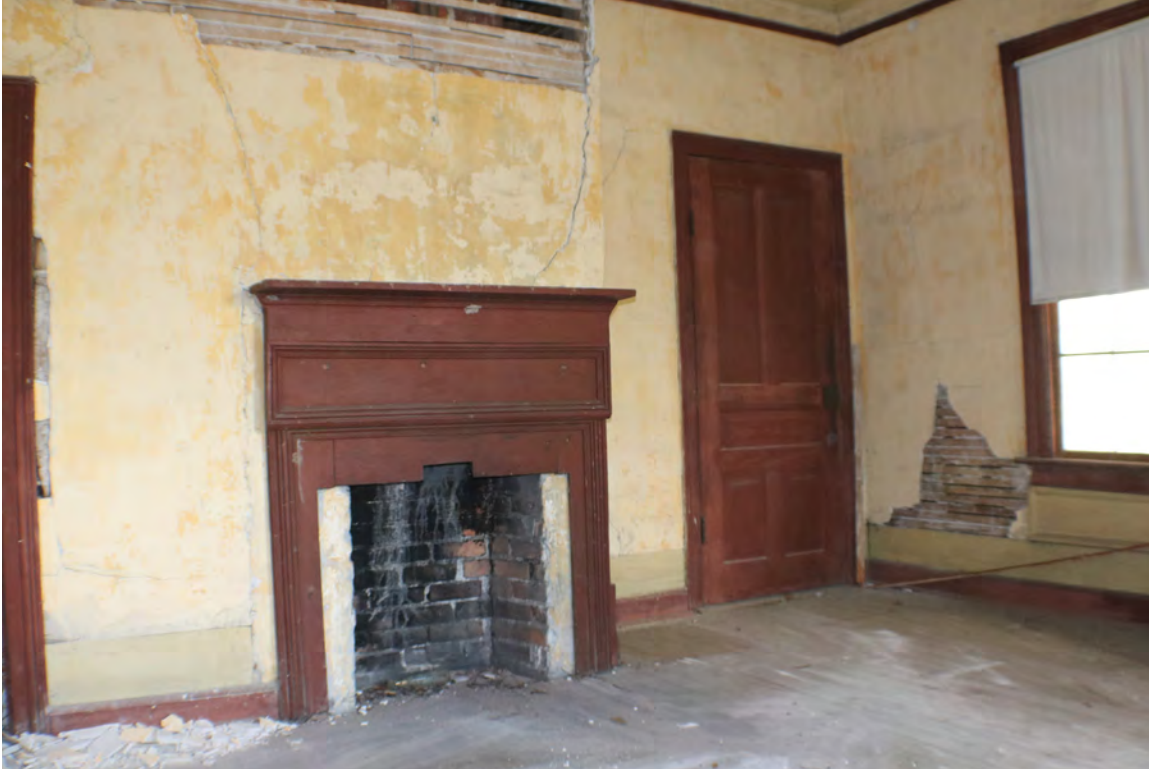
Figure 49: Epps-McGill Farmhouse - PHASE 02: View of typical five panel interior wood doors (Kalen McNabb 2020).

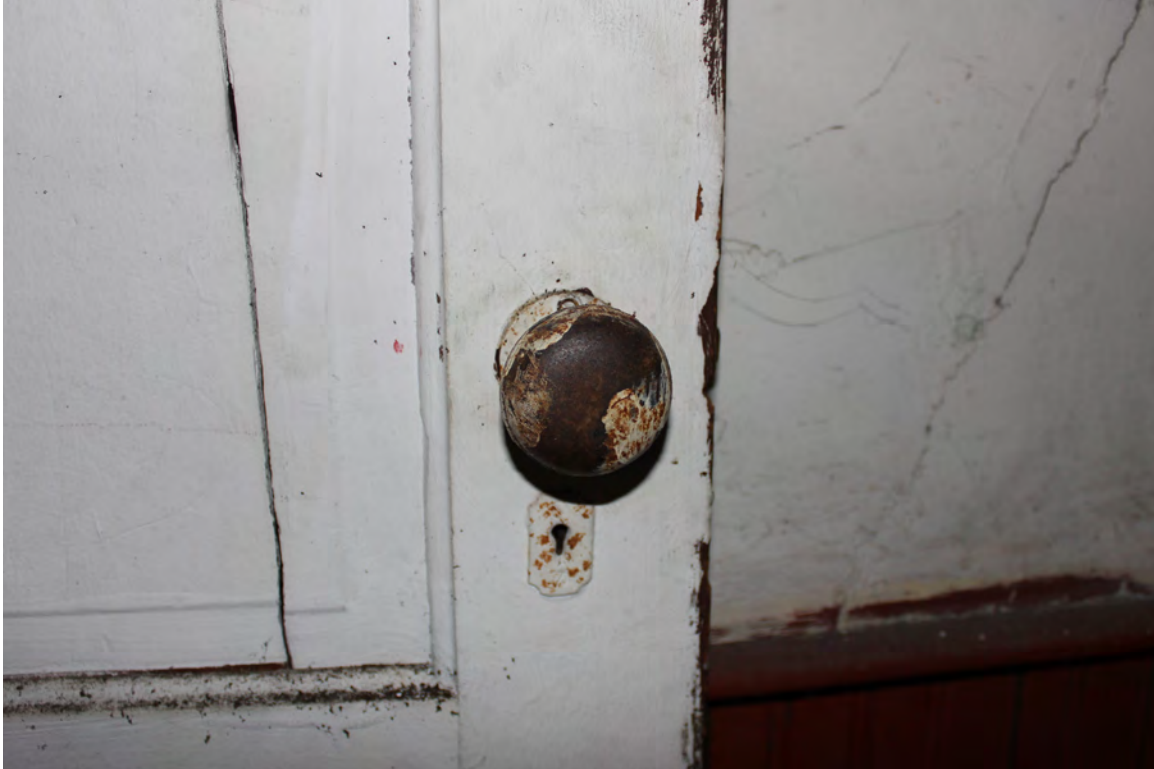
Figure 51: Epps-McGill Farmhouse - PHASE 02: Detail of door hardware. All original door hardware will be preserved and repaired (Kalen McNabb 2020).

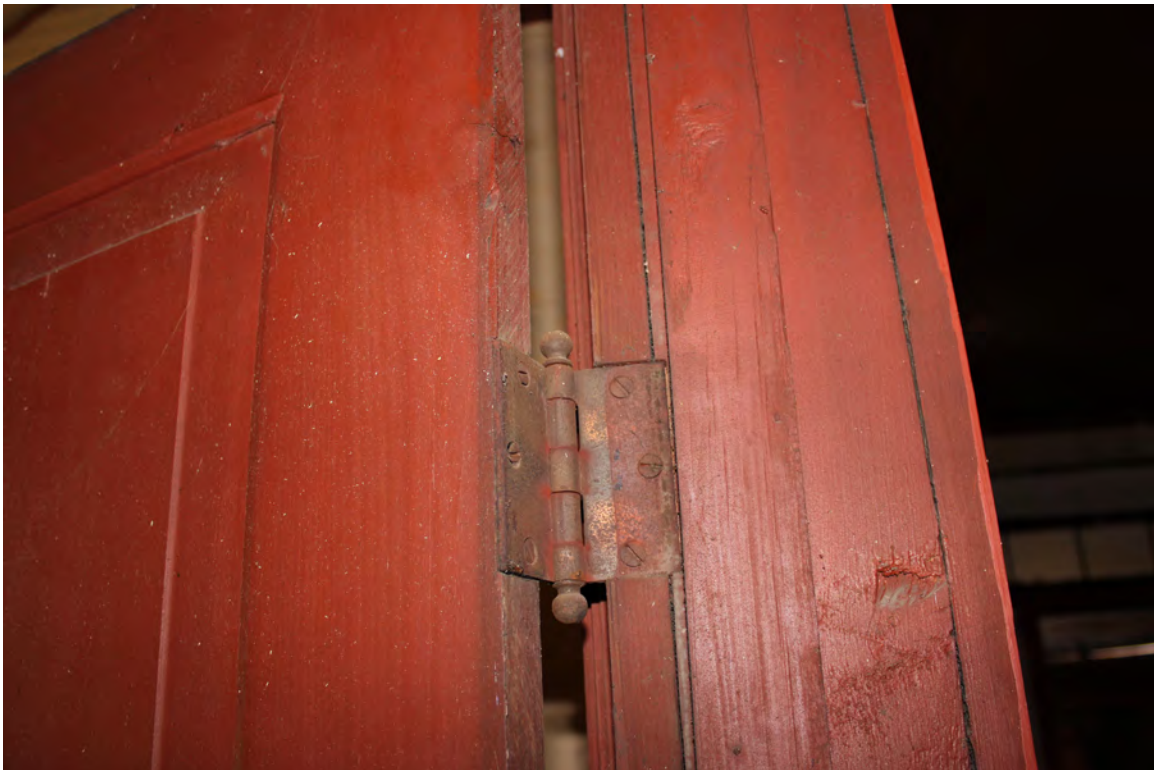
Figure 52: Epps-McGill Farmhouse - PHASE 02: Detail of door hinges. All hardware will be preserved (Kalen McNabb 2020).

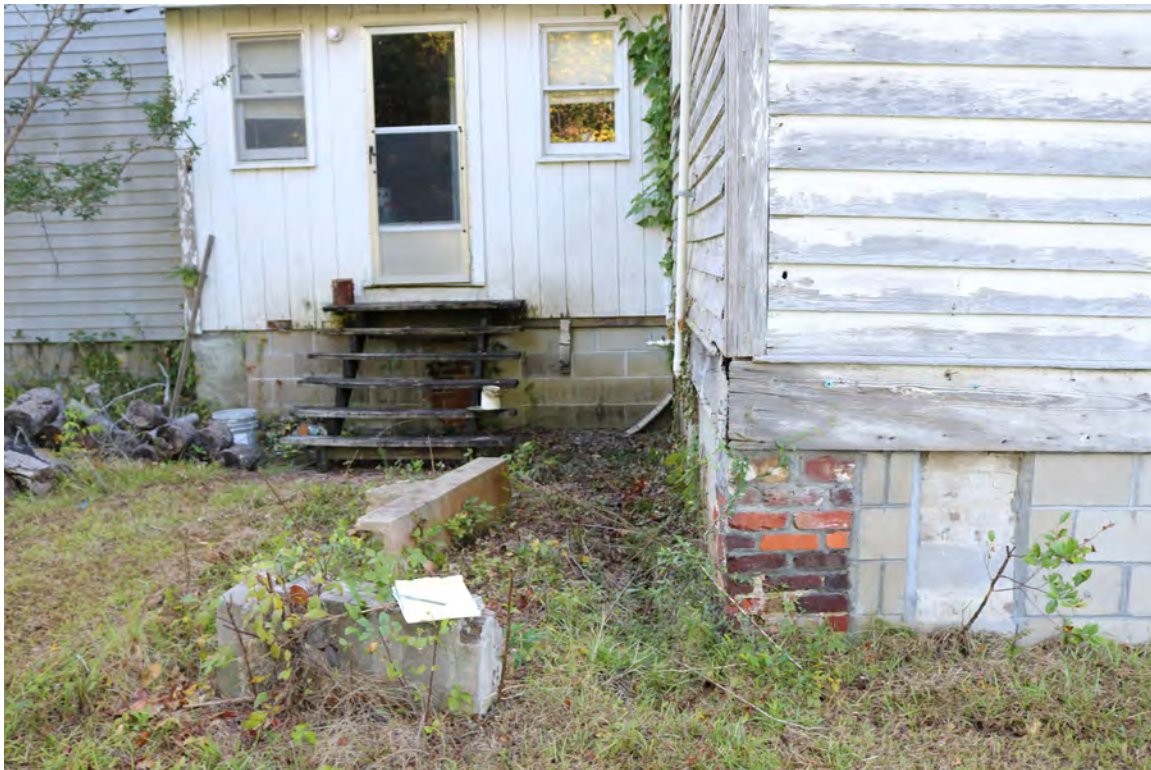
Figure 54: Epps-McGill Farmhouse - PHASE 02: View of location of deck and ramp. The existing modern wood stair is deteriorated and lacks a railing (Kalen McNabb 2020).

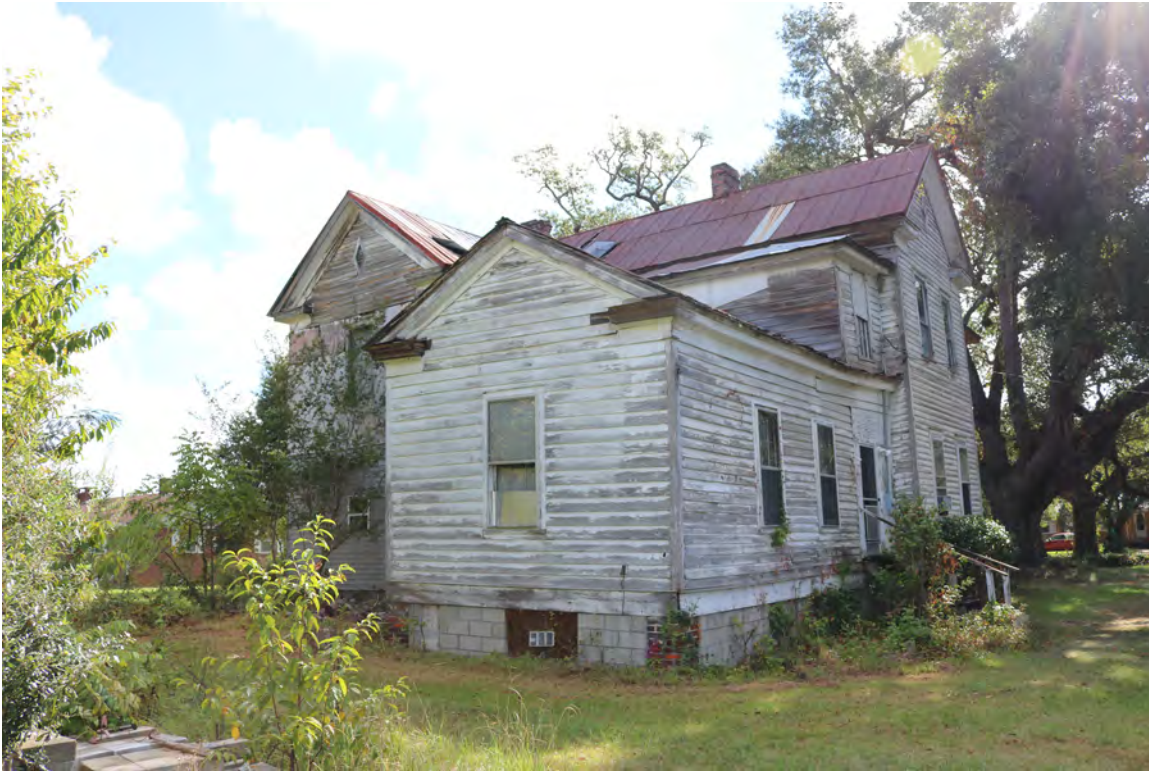
Figure 55: Epps-McGill Farmhouse - PHASE 02: The proposed ramp will wrap around the one-story kitchen building (Kalen McNabb 2020).

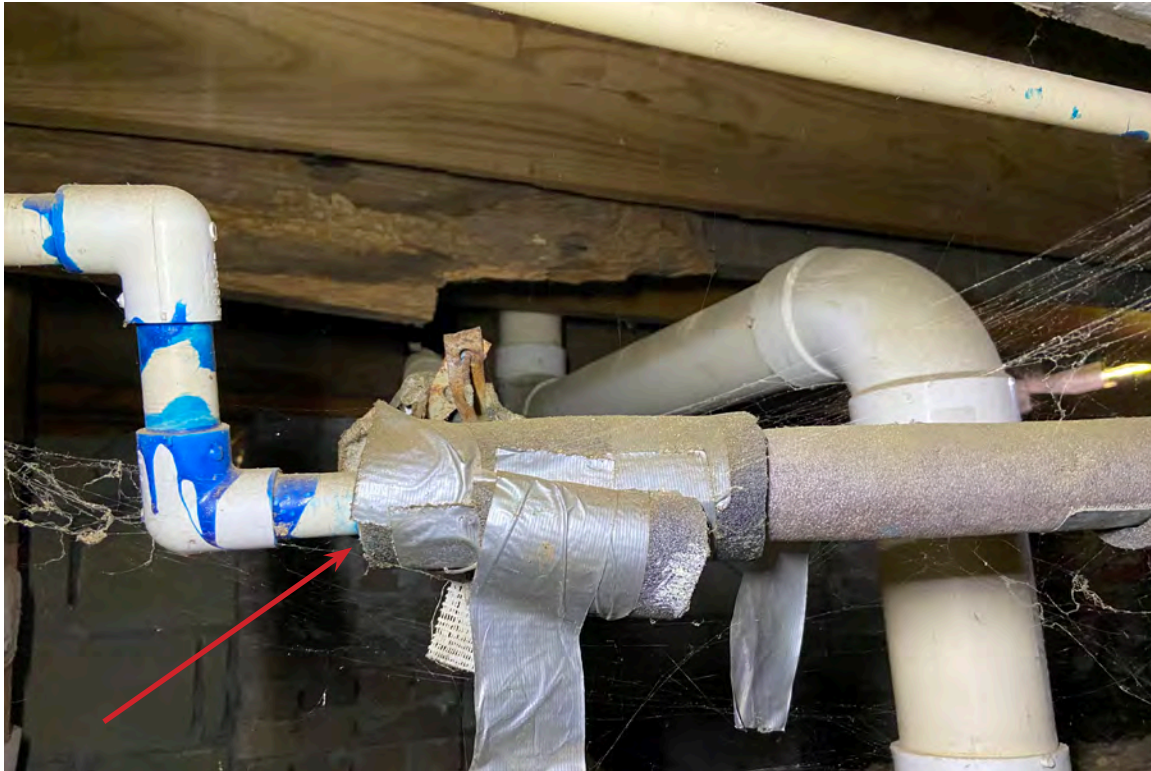
Figure 59: Epps-McGill Farmhouse - PHASE 02: Detail of leaking modern plumbing beneath the first-floor bathrooms (Kalen McNabb 2020).

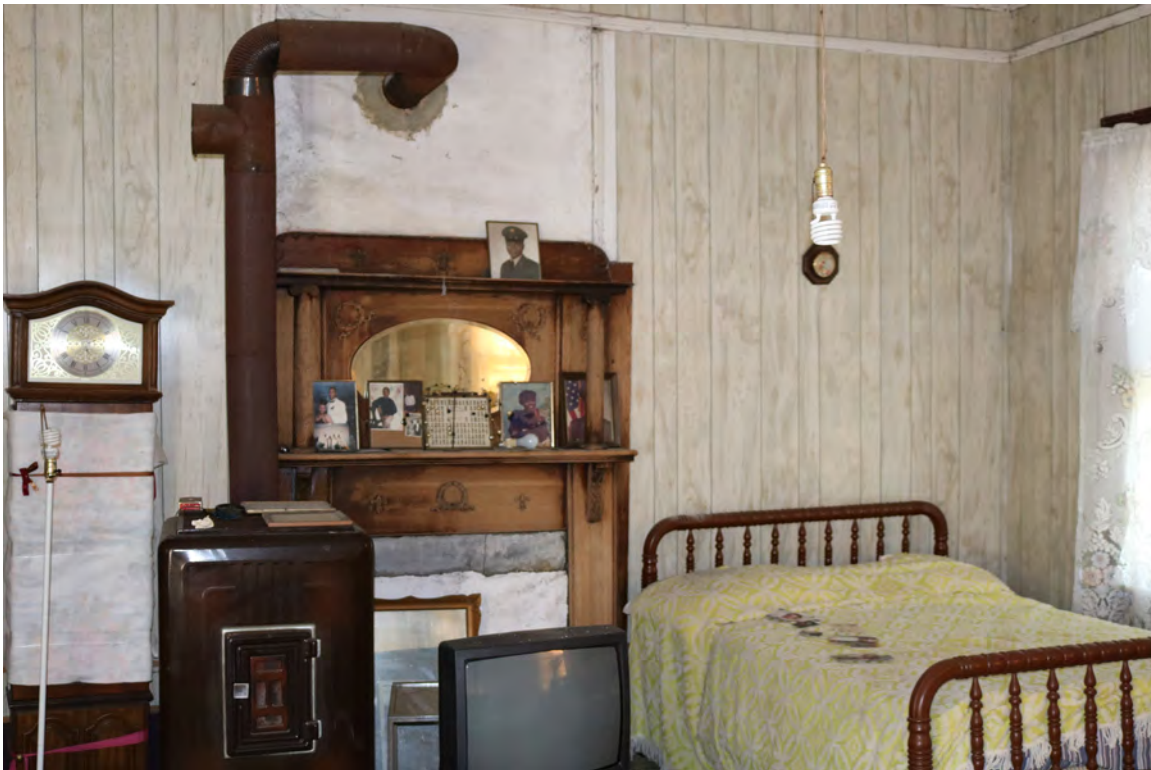
Figure 60: Epps-McGill Farmhouse - PHASE 02: Outdated wiring and light fixtures are present throughout the house (Kalen McNabb 2020).

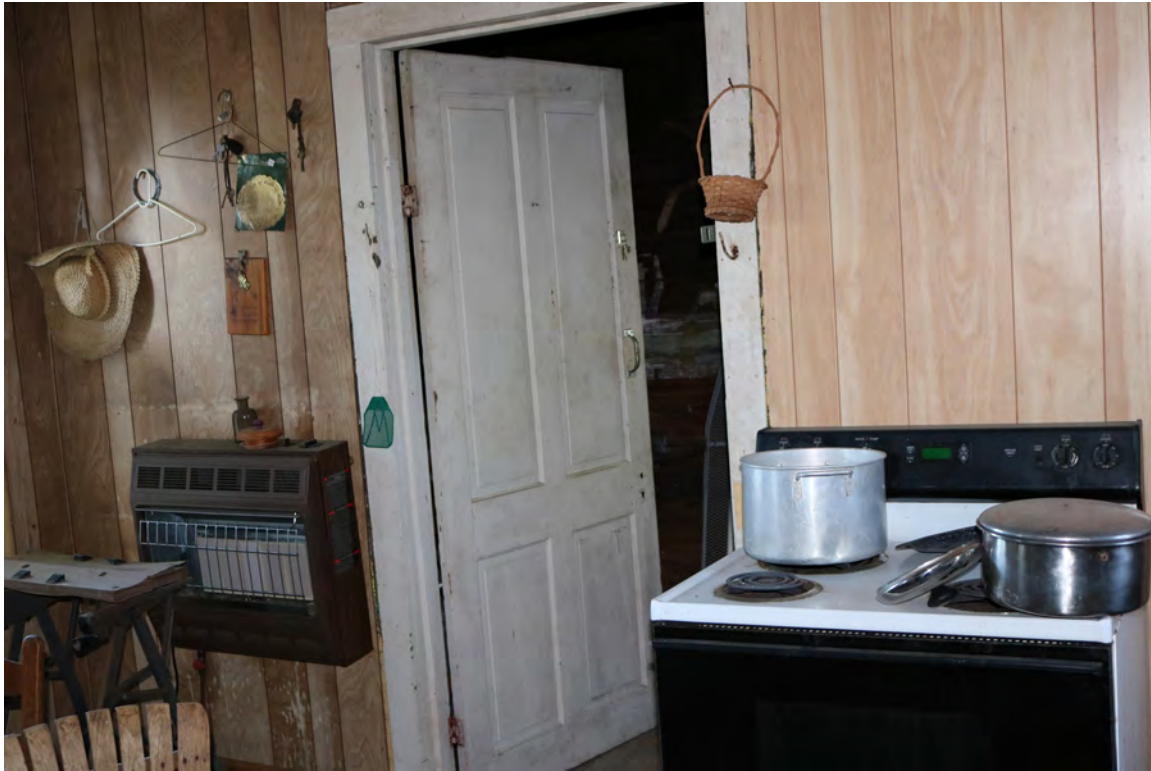
Figure 67: Epps-McGill Farmhouse - PHASE 02: View of Modern Kitchen to Be Replaced (Kalen McNabb 2020).

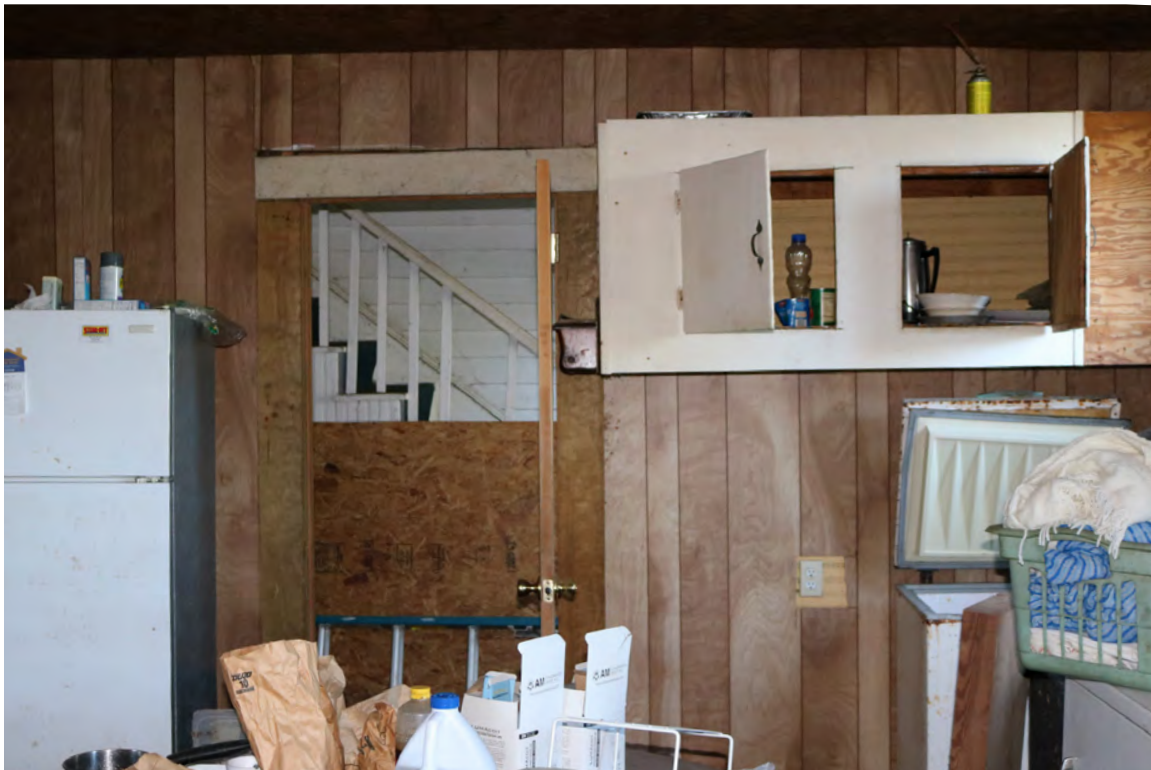
Figure 68: Epps-McGill Farmhouse - PHASE 02: View of Modern Kitchen to Be Replaced (Kalen McNabb 2020).
