PROJECT MANUAL APPENDIX EPPS-MCGILL FARMHOUSE

MEADORS, Inc.

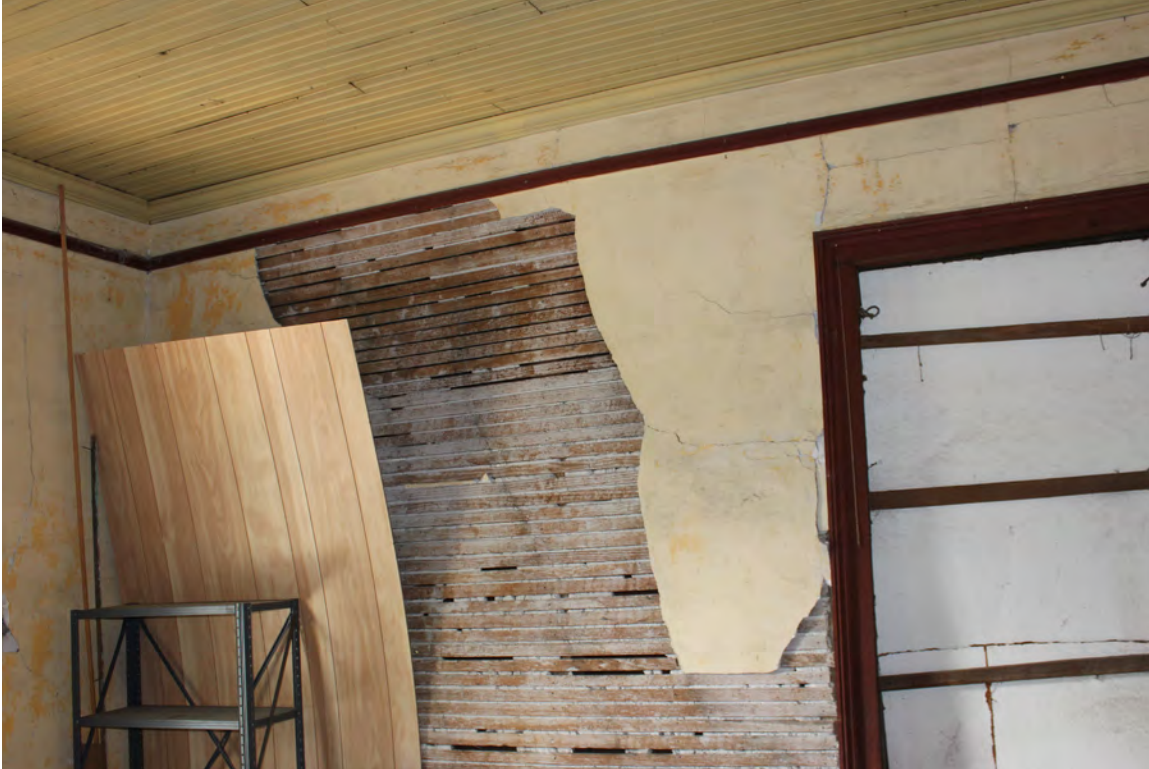
Figure 75: Epps-McGill Farmhouse - PHASE 02: Damaged plaster will be repaired in-kind (Kalen McNabb 2020).

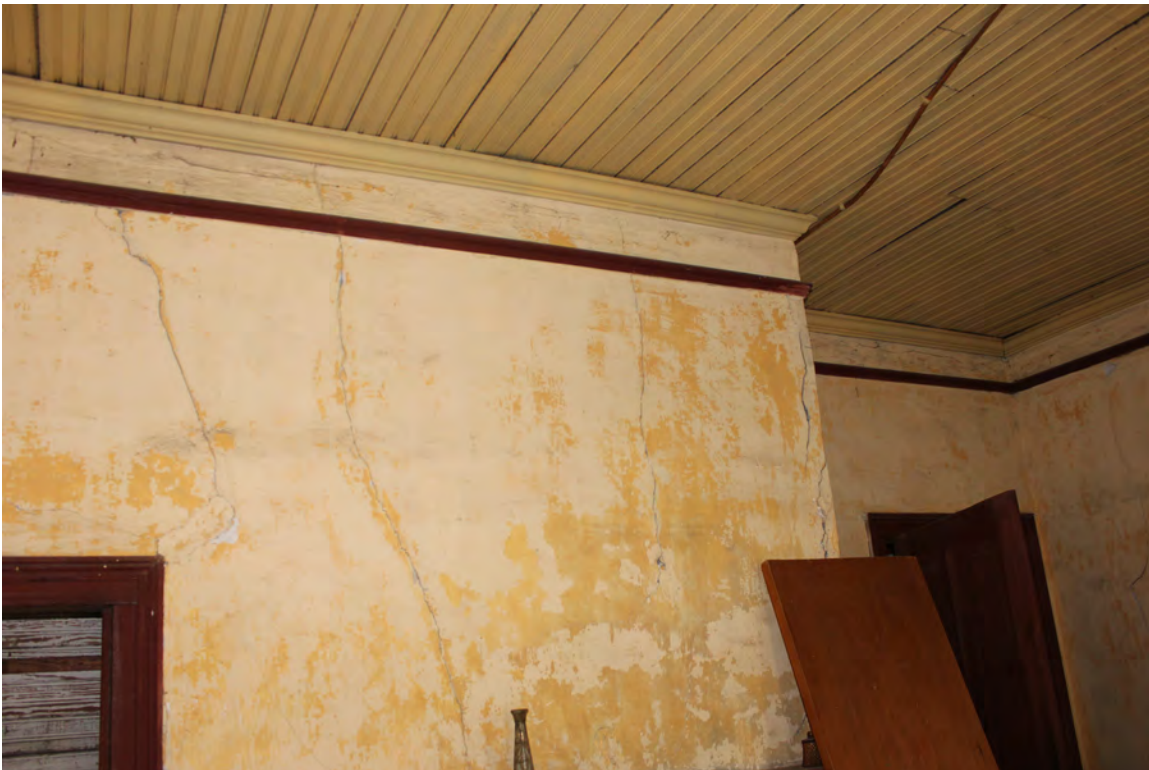
Figure 76: Epps-McGill Farmhouse - PHASE 02: View of extant flat plaster damage (Kalen McNabb 2020).

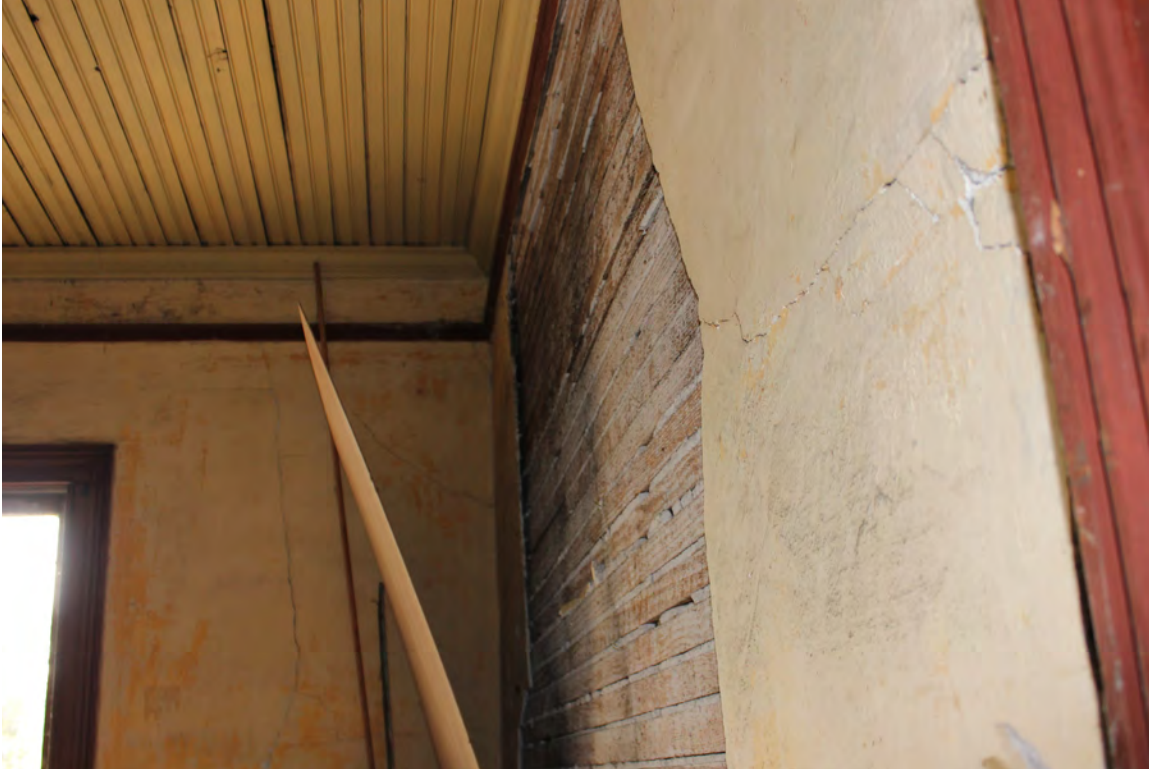
Figure 77: Epps-McGill Farmhouse - PHASE 02: View of historic wall finishes in a variety of conditions (Kalen McNabb 2020).

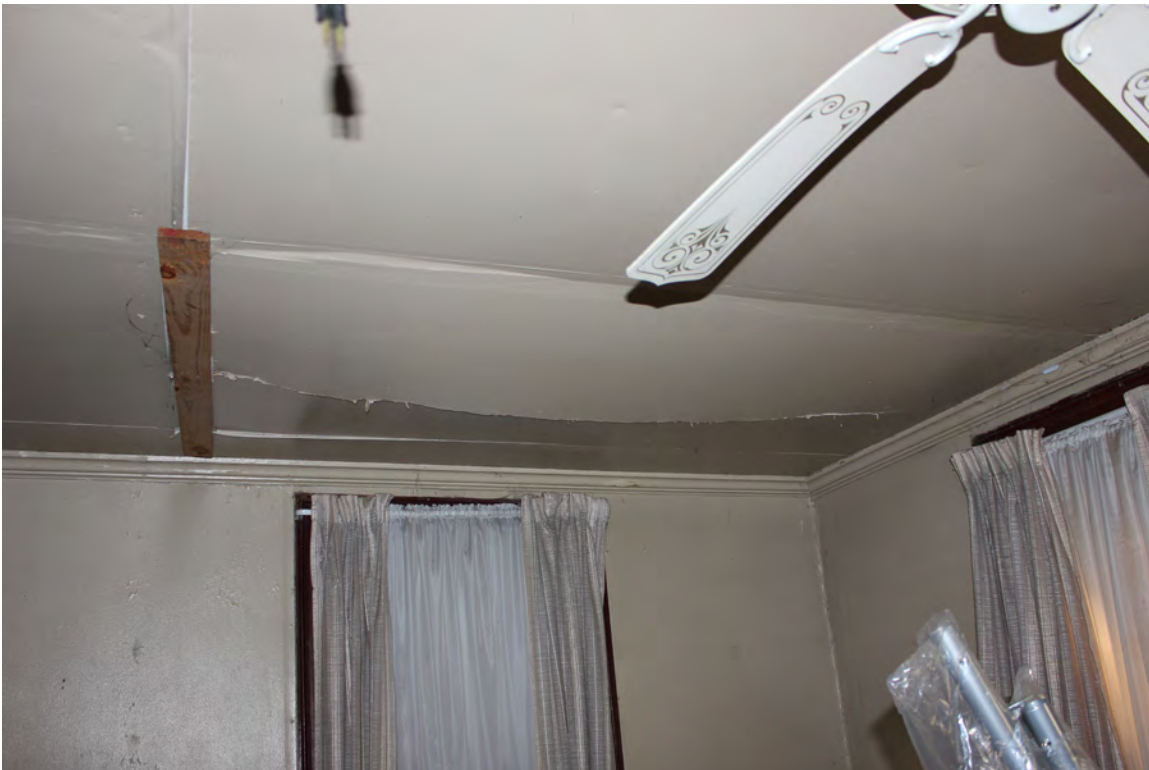
Figure 78: Epps-McGill Farmhouse - PHASE 02: View of modern ceiling finishes which are now failing (Kalen McNabb 2020).

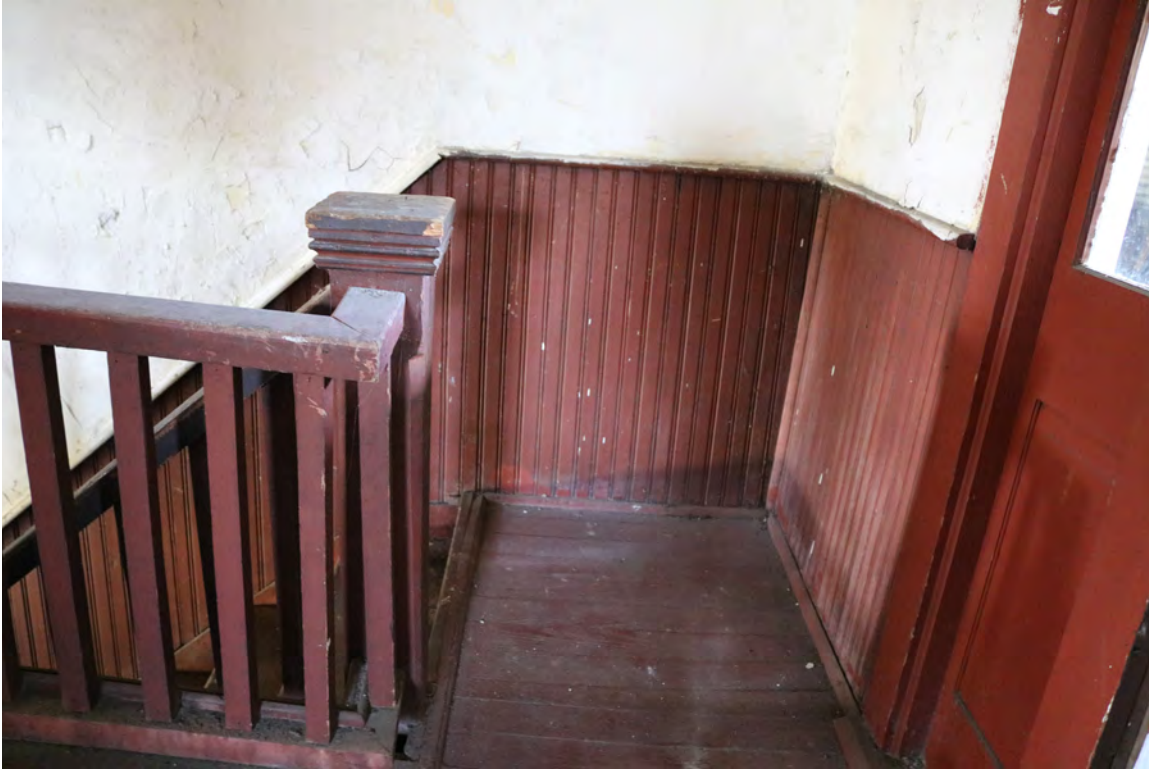
Figure 79: Epps-McGill Farmhouse - PHASE 02: View of second-floor beadboard wainscoting (Kalen McNabb 2020).

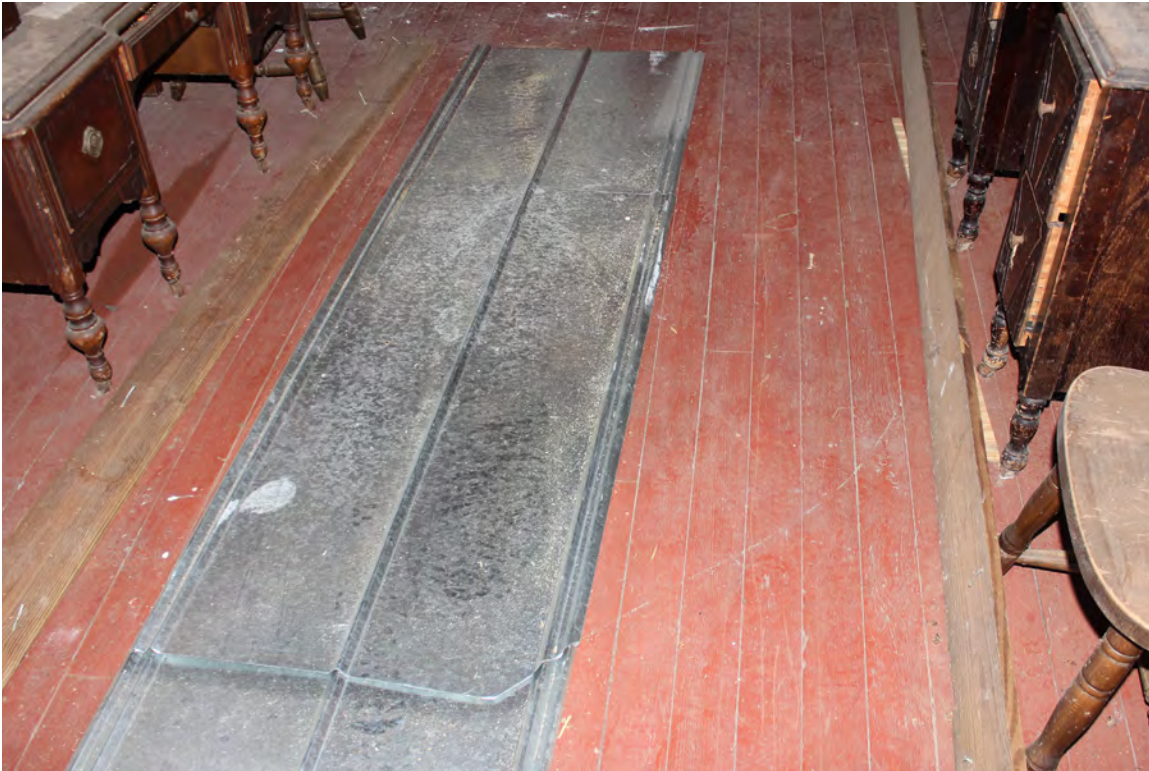
Figure 81: Epps-McGill Farmhouse - PHASE 02: The historic floors are in fair condition and will be preserved during this phase of work (Kalen McNabb 2020).

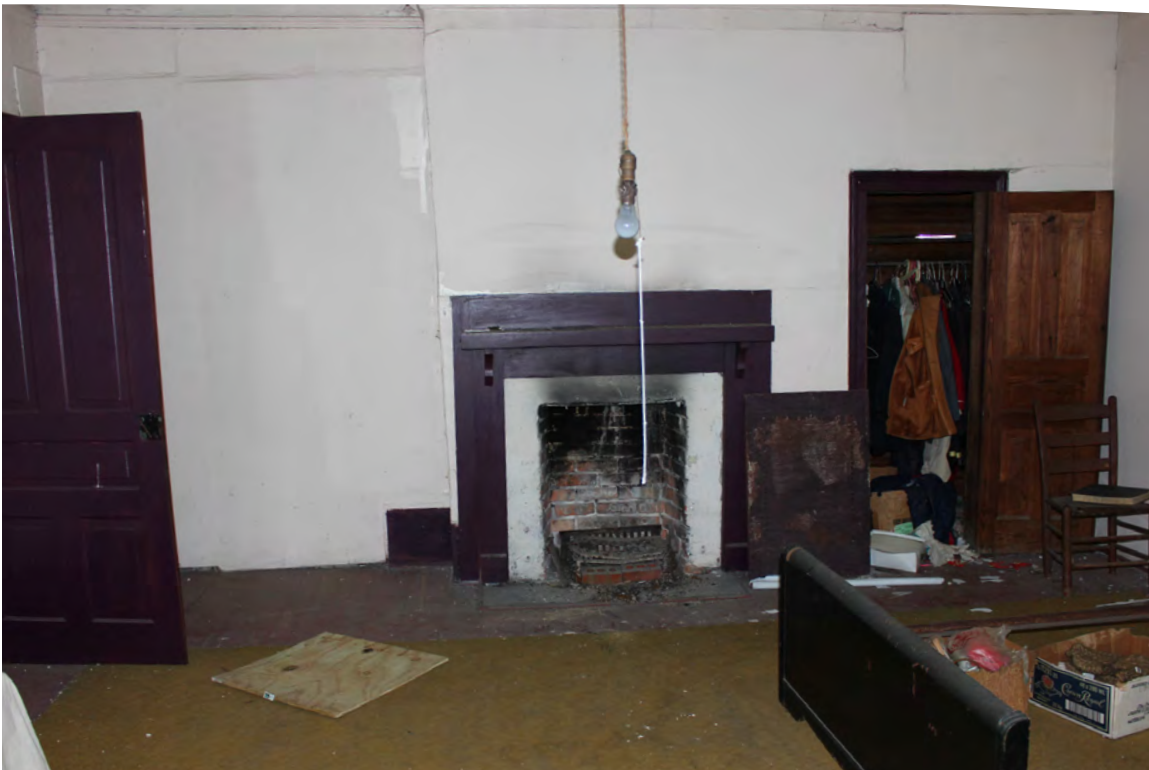
Figure 82: Epps-McGill Farmhouse - PHASE 02: The historic floors are present beneath existing carpet. The carpet will be removed and the underlying floor will be restored (Kalen McNabb 2020).

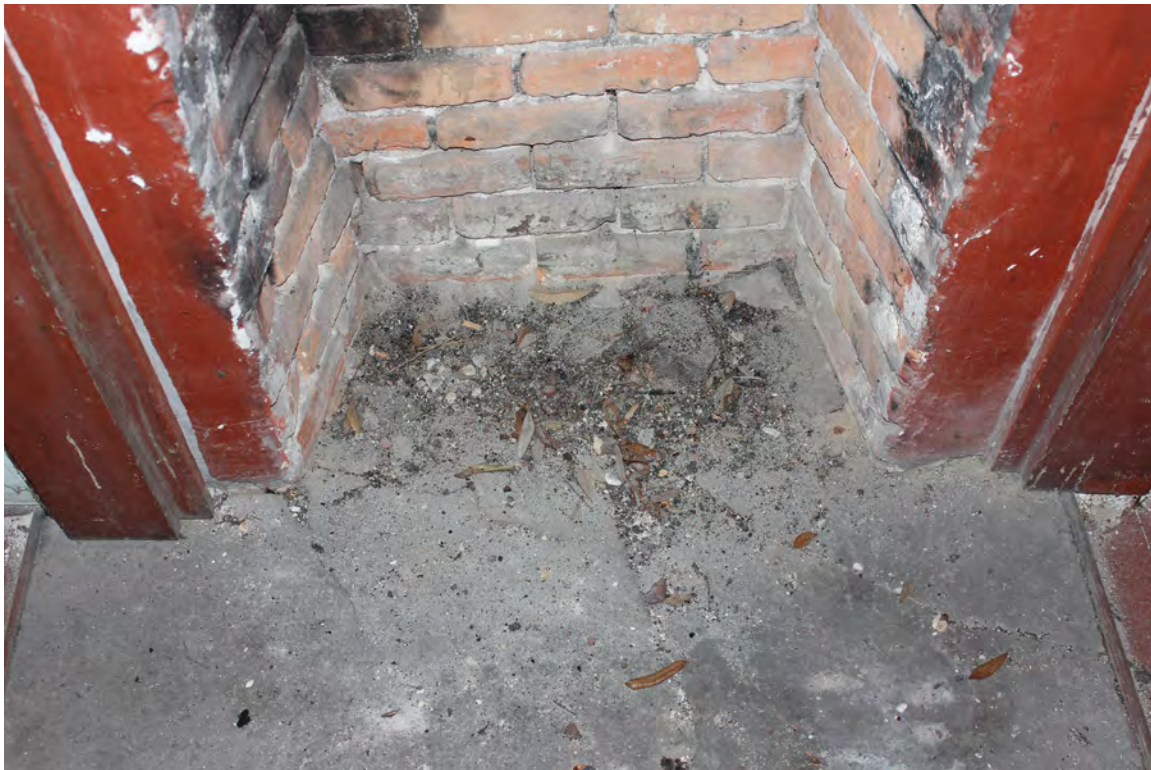
Figure 88: Epps-McGill Farmhouse - PHASE 02: View of condition of the firebox within Room 204 (Kalen McNabb 2020).

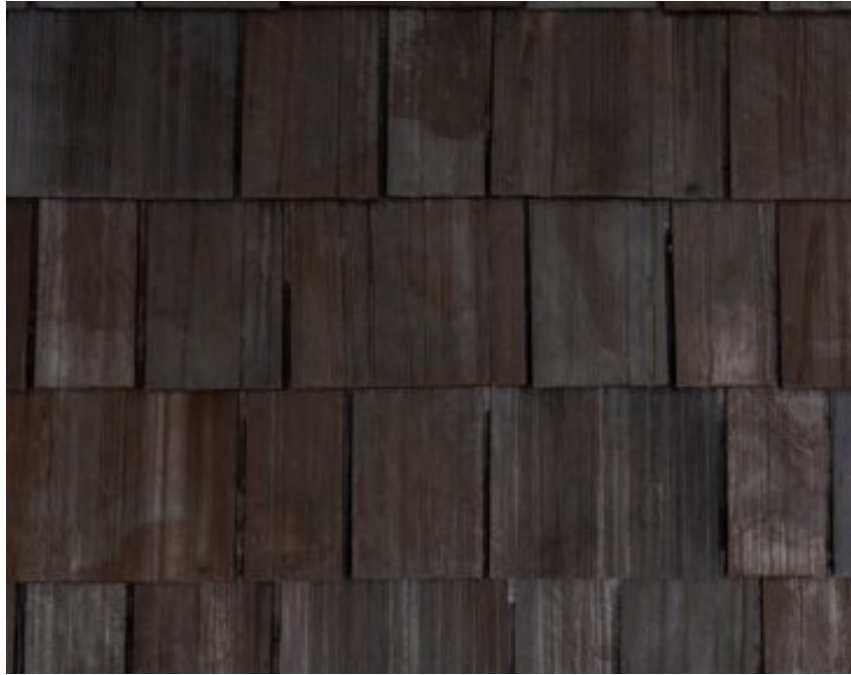
Figure 1: Epps-McGill Farmhouse - View of the Brava Cedar Shake in “Aged”.
